Milestone Inspection – Phase 1

Lake Tarpon Sail and Tennis Club III

90 S. Highland Ave. Building A Tarpon Springs, FL 34689

April 9, 2024

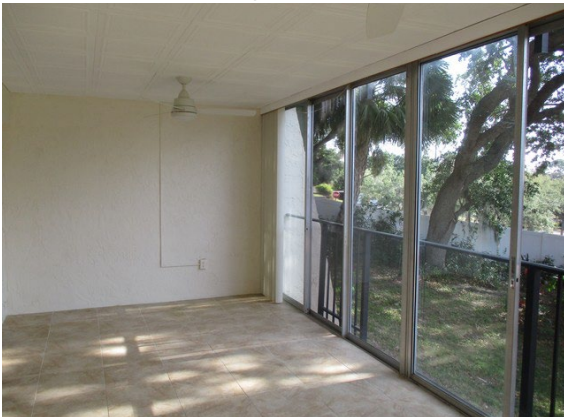
- Building A, Unit #102 (not actual balcony)
 - No concerns of note

5 Unit #102 (Not Actual Balcony)

For the Balconies, we do not recommend that the balconies have a Phase 2 destructive testing performed. We recommend that the painting/waterproofing schedule is strictly adhered to. As part of a yearly inspection, we recommend that any surficial cracks developing are sealed with elastomeric sealer between formal painting cycles. No modifications to the balconies such as tile or carpet should be allowed by the COA without approval of the Board or Architectural Review Committee along with receiving plans on how the waterproofing both under the tiles and at the end walls are achieved.

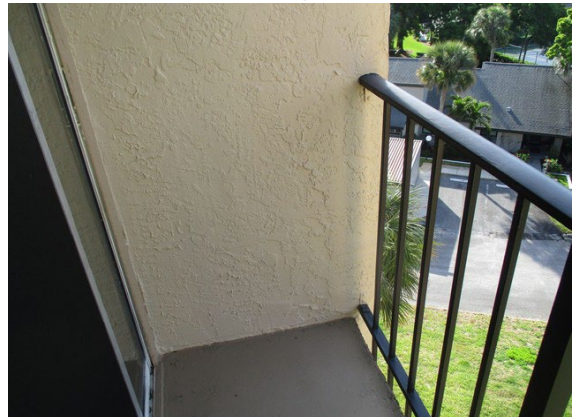
- Building A, Unit #401
 - No concerns of note

6 Unit #401 Balcony

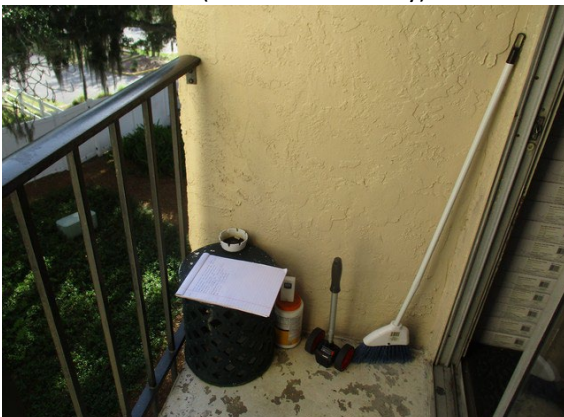
- Building A, Unit #302
 - No concerns of note

7 Unit #302 Balcony

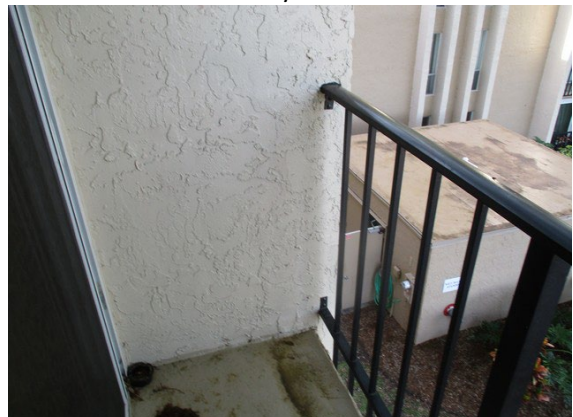
- Building A, Unit #312
 - No concerns of note

8 Unit #312 Balcony

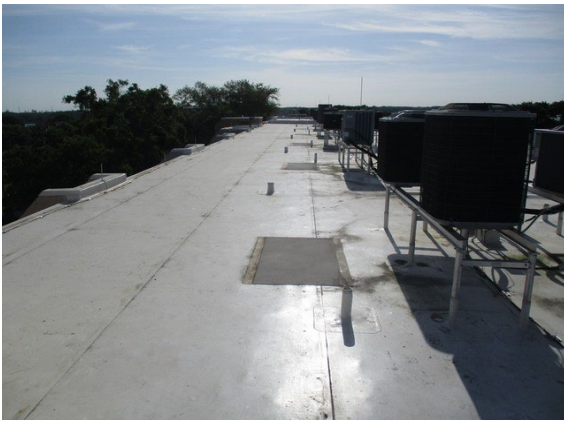
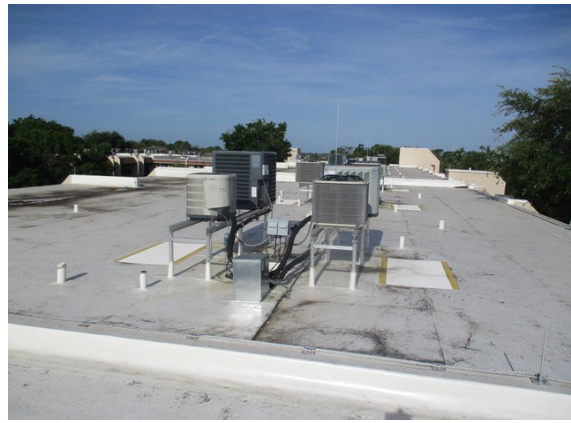
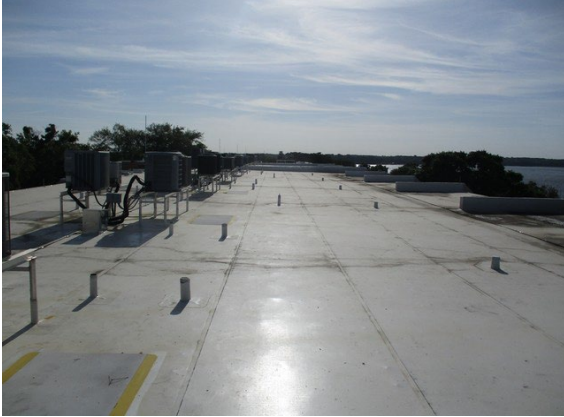
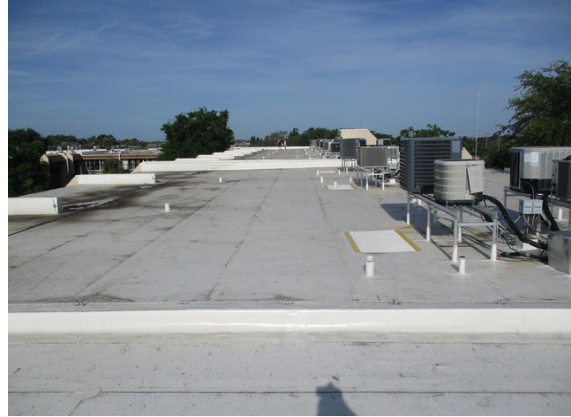
- Building #A
 - No concerns of note

9 Roof Overview

For the flat roof, we do not recommend that the roof have a Phase 2 thermal inspection performed at this time. However, Annual roof inspections, as well as post-storm roof inspections, should be performed to allow for quick remediation of issues that can prevent structural impact on the framing.

For the shingle roof, any missing or creased shingles should be repaired immediately when observed to be deteriorated. Annual roof inspections, as well as post-storm roof inspections, should be performed to allow for quick remediation of issues that can prevent structural impact on the framing.

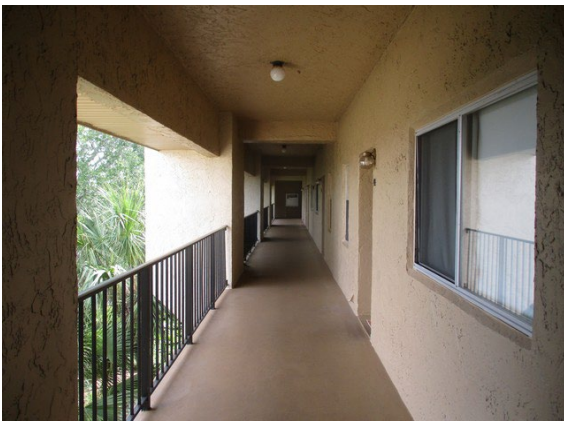
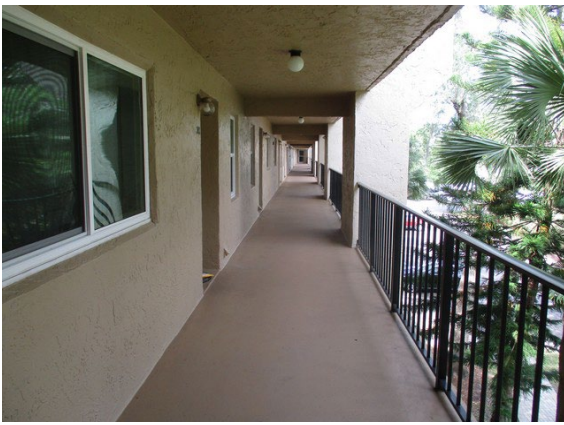
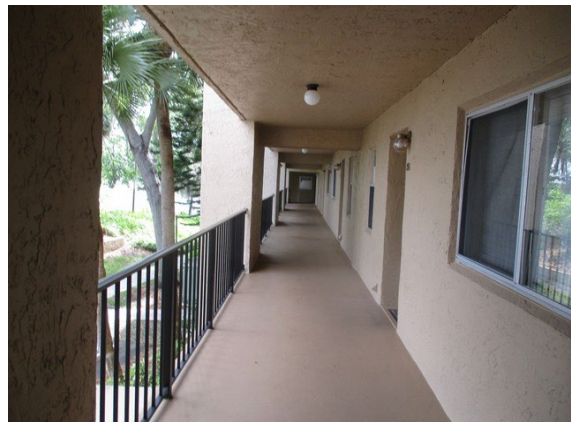
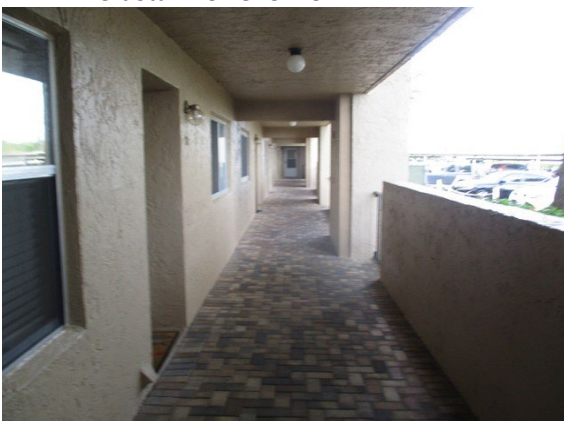
- Building A, Level 1
 - No concerns of note
- Building A, Level 2
 - No concerns of note
- Building A, Level 3
 - No concerns of note
- Building A, Level 4
 - No concerns of note

13 4th Floor Walkway Overview

For the Exterior Walls/Breezeways, we do not recommend that the breezeways and walls have a Phase 2 destructive testing performed. We recommend that the painting/waterproofing schedule is strictly adhered to. As part of a yearly inspection, we recommend that any surficial cracks developing are sealed with elastomeric sealer between formal painting cycles.

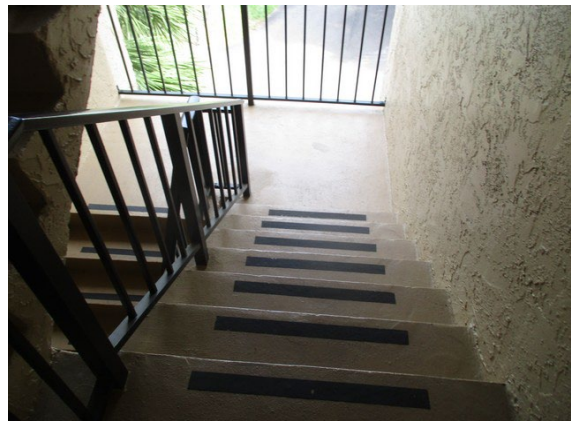
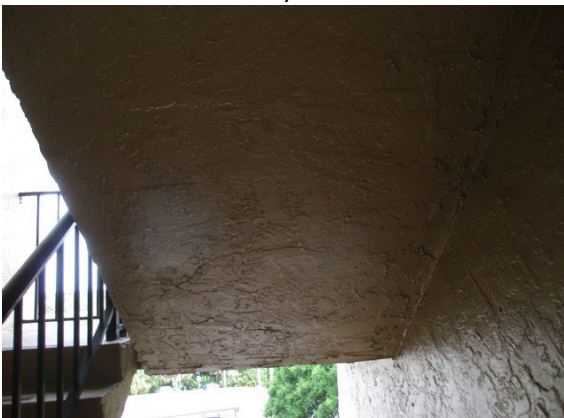
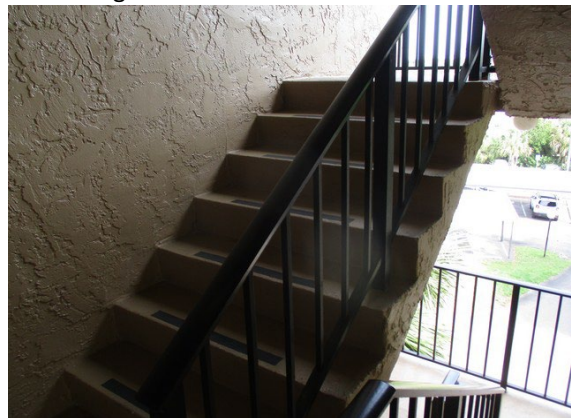
- Stairs at the right side of Building #A
 - No concerns of note
- Stairs at the center of Building #A
 - No concerns of note
- Stairs at the left side of Building #A
 - No concerns of note

14 Right Stairwell Overview

For the stairs, we do not recommend that the stairs have a Phase 2 destructive testing performed as there was no concern with structural compromising at the time of inspection. When the breezeways/walkways are sealed, we recommend that the stairs are included to help prevent future structural issues caused by water infiltration as part of a preventative maintenance plan.

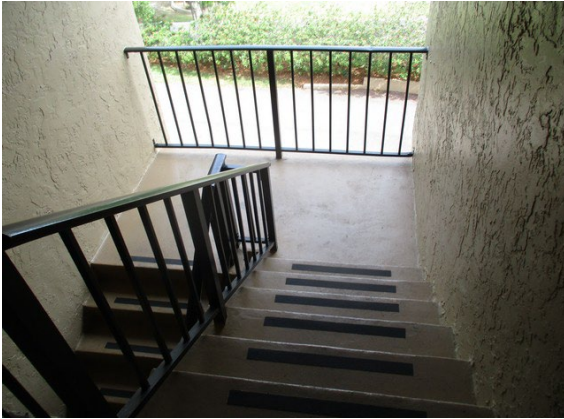
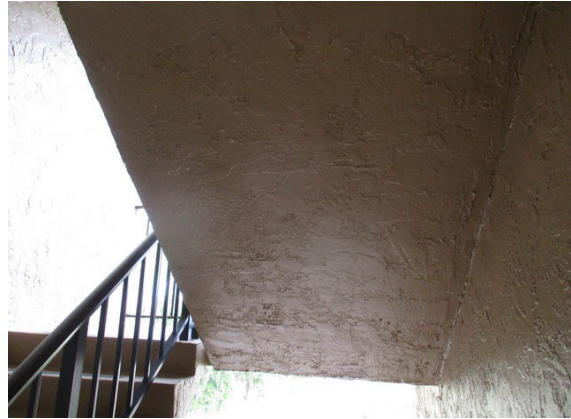
19 Center Stairwell Overview

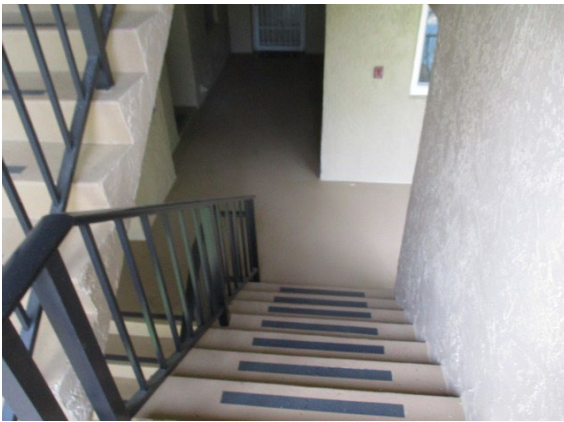
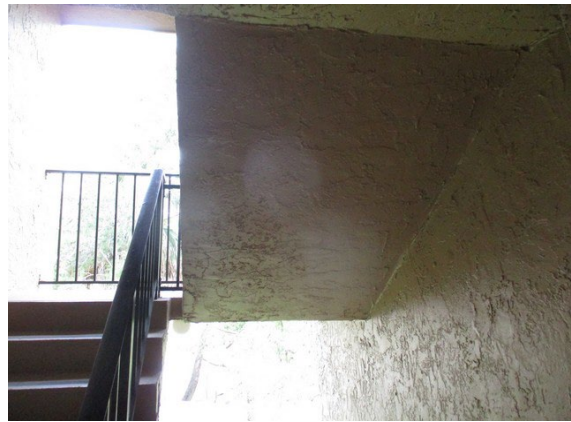
21 Left Stairwell Overview
