## **Milestone Inspection – Phase 1**

### **Lake Tarpon Sail and Tennis Club III**

90 S. Highland Ave. Building B Tarpon Springs, FL 34689

**April 9, 2024**

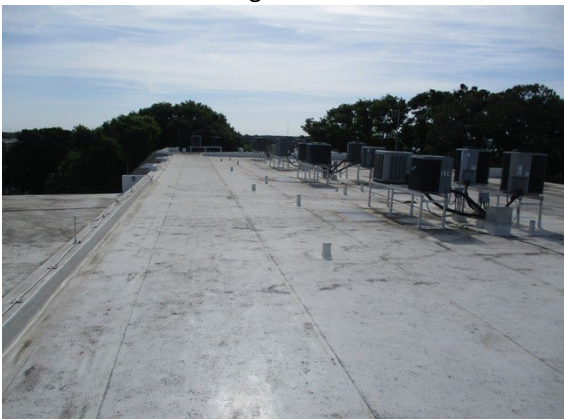
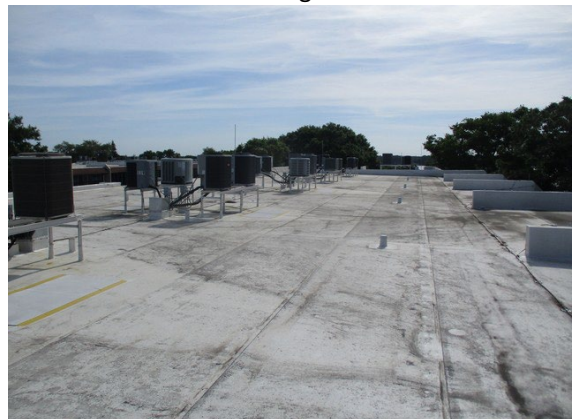
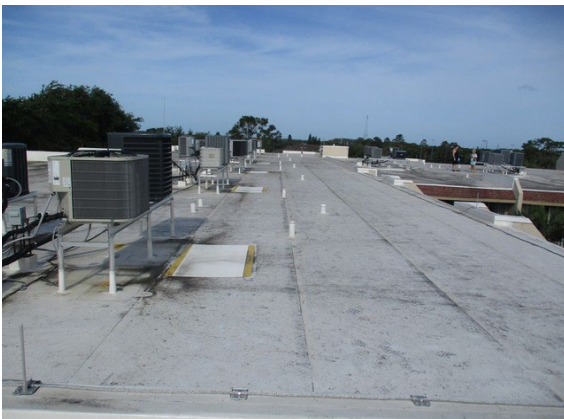
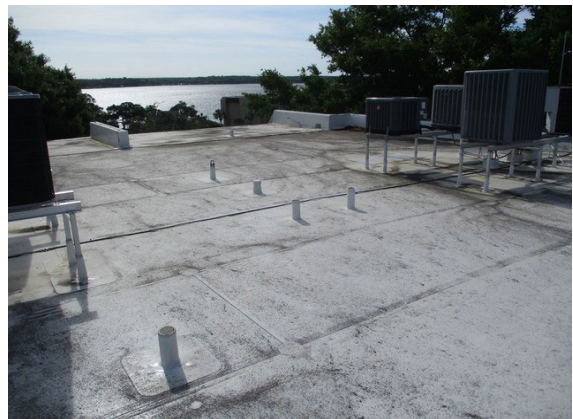
The observable roof structure was consistent with a predominantly Flat roof design covered with TPO. There was a secondary accent roof. That secondary accent roof was covered with Dimensional Shingle. Roof run-off is contained within adequate gutters. The primary roof covering was approximately 20 years old and has a traditional useful life of 20 years. The secondary roof covering was approximately 2 years old and has a traditional useful life of 25 years. Beryl did not note issues at the time of inspection that could result in a lower-than-expected service life for the roofing system. Below is a detailed breakdown of the issues at each building by location and type that we observed by building number if applicable:

- Building #B
  - No concerns of note

For the flat roof, we do not recommend that the roof have a Phase 2 thermal inspection performed at this time. However, Annual roof inspections, as well as post-storm roof inspections, should be performed to allow for quick remediation of issues that can prevent structural impact on the framing.

For the shingle roof, any missing or creased shingles should be repaired immediately when observed to be deteriorated. Annual roof inspections, as well as post-storm roof inspections, should be performed to allow for quick remediation of issues that can prevent structural impact on the framing.

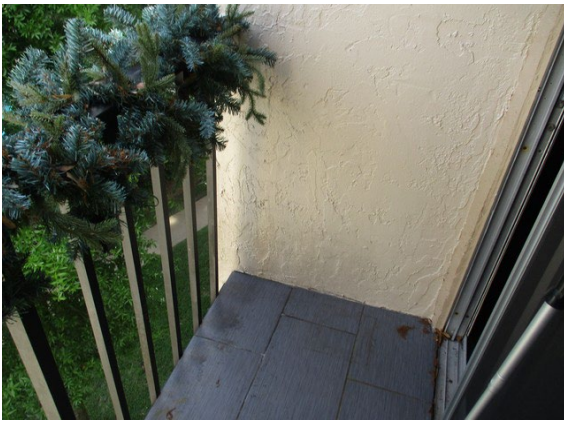
9 Unit #424 Balcony

- Building B, Unit #424
  - No concerns of note

For the Balconies, we do not recommend that the balconies have a Phase 2 destructive testing performed. We recommend that the painting/waterproofing schedule is strictly adhered to. As part of a yearly inspection, we recommend that any surficial cracks developing are sealed with elastomeric sealer between formal painting cycles. No modifications to the balconies such as tile or carpet should be allowed by the COA without approval of the Board or Architectural Review Committee along with receiving plans on how the waterproofing both under the tiles and at the end walls are achieved.

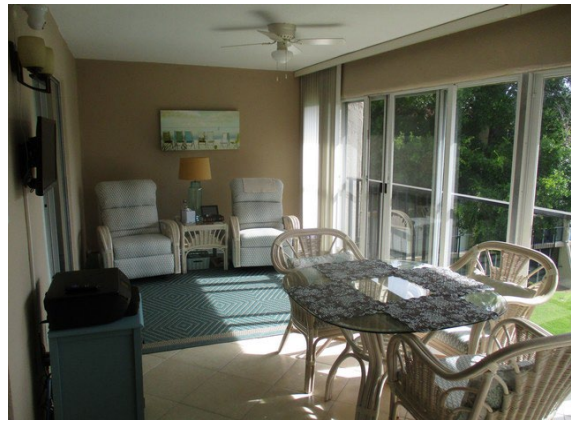
10 Unit #415 (Not Actual Balcony)

- Building B, Unit #415 (not actual balcony)
  - No concerns of note

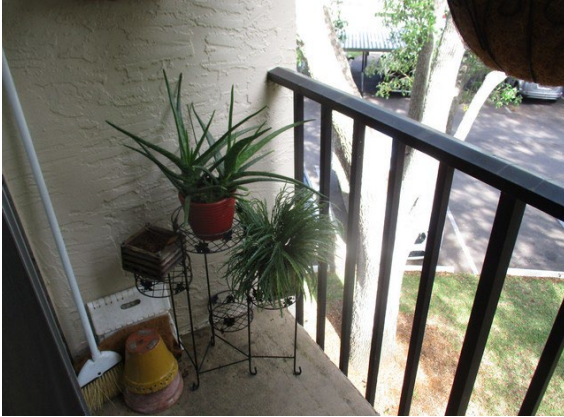
11 Unit #313 Balcony

- Building B, Unit #313
  - No concerns of note

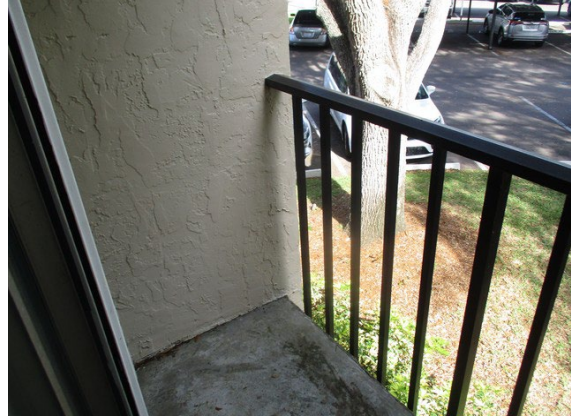
12 Unit #213 Balcony

- Building B, Unit #213
  - No concerns of note

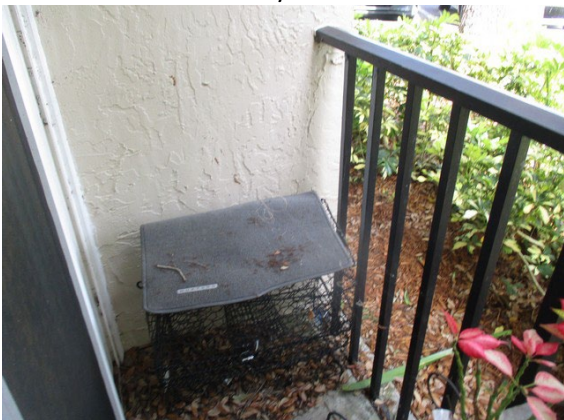
13 Unit #113 Ground Floor Balcony/Porch

- Building B, Unit #113
  - No concerns of note
