To:Lake Tarpon Sail and Tennis Club IIIFrom:Leo Cannyn, PMP, P.E., Principal Project ManagerSubject:90 S Highland Ave, Tarpon Springs, FL 34689 Engineering AffidavitDate:2/14/2025

Beryl Engineering & Inspection, LLC ("Beryl") was retained by Lake Tarpon Sail and Tennis Club III with regards to inspection located at 90 S Highland Ave, Tarpon Springs, FL 34689. According to the Pinellas County Property Appraiser Website, the buildings were built in 1983. The structural systems are consistent with a Slab on Grade foundation with Concrete Masonry Unit (CMU) walls clad in Stucco veneer. The roof structure is consistent with a predominantly Flat roof design covered with TPO. There is a secondary accent Mansard roof covered with Dimensional Shingles. Beryl was asked to inspect the roofs of buildings A and B, as well as the interior of the units experiencing water intrusion issues at the sliding glass doors.

The primary purpose of this letter is for Beryl, as Engineer, to certify that at the time of their review on 2/14/2025 we found that the roofs of buildings A and B were replaced in 2022. It was reported that the roofer explained that the existing internal perimeter drain was no longe

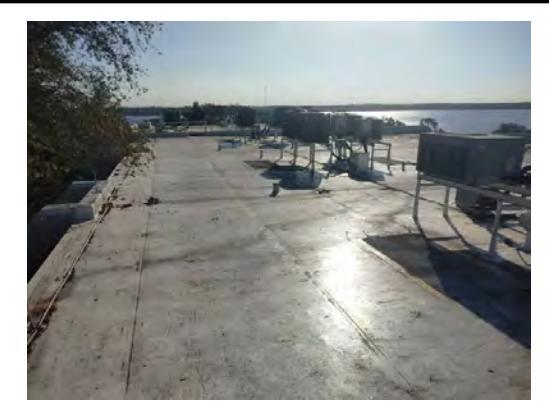
1. Several dark areas and low spots were observed on the TPO roof covering of both buildings. Typically, dark spots or staining on the roofing material are the result frequent water pooling.

- Water evaporation leaves behind dirt, dust, and organic matter, creating dark stains in areas where water has pooled.
- Standing water was also observed, which promotes the growth of algae, mold, or mildew, and can appear as dark spots or streaks.

Prolonged exposure to ponding water can degrade the TPO membrane, causing discoloration, leaks, and premature failure. Standing water also increases the load on the roof, which can lead to sagging or collapse.

31 Observed Staining - Flat Roof Building A

Additionally, it would be prudent to ensure the roof has at least 1/4 inch per foot slope to direct water toward drains or scuppers. If the slope is insufficient or there are low spots, water can pond and seep into the roofing membrane. The use of insulation boards to create a slope in low areas can repair low spots or depressions that hold water. Tapered insulation is a cost-effective way to ensure proper roof slope and improve drainage on an existing flat roof.

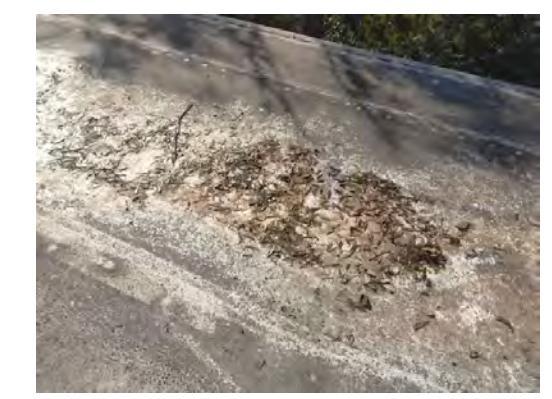
30 Observed Staining - Flat Roof Building A

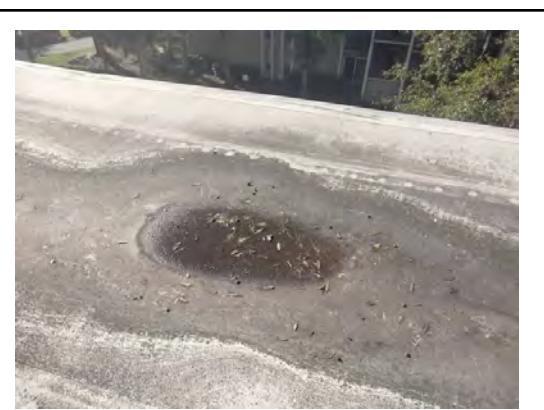
The National Roofing Contractors Association (NRCA) defines ponding water as any water that remains on a roof for more than 48 hours after rainfall stops. Over time, ponding water can exploit weaknesses in roof flashing, seams, or penetration points (e.g., HVAC units, vents) and penetrate insulation, ceilings, and walls.

33 Observed Ponding Water - Flat Roof Building A

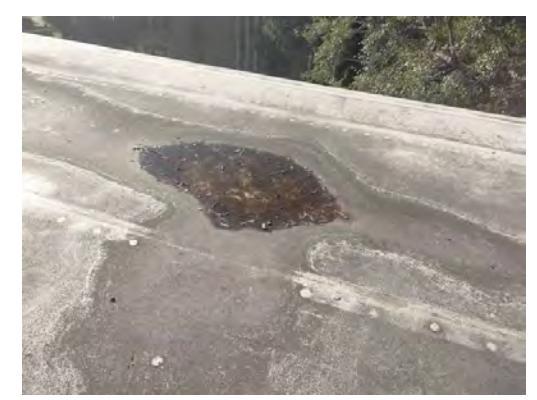
39 Observed Ponding Water - Flat Roof Building A

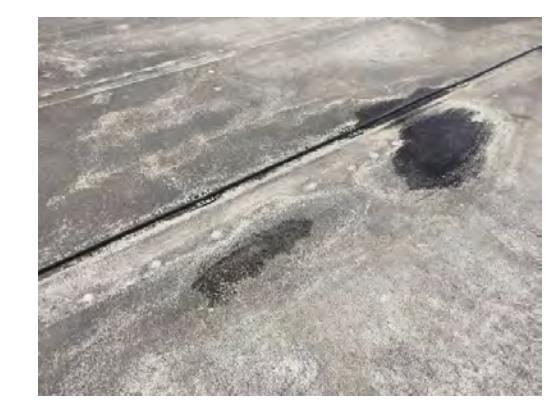
38 Observed Ponding Water - Flat Roof Building A

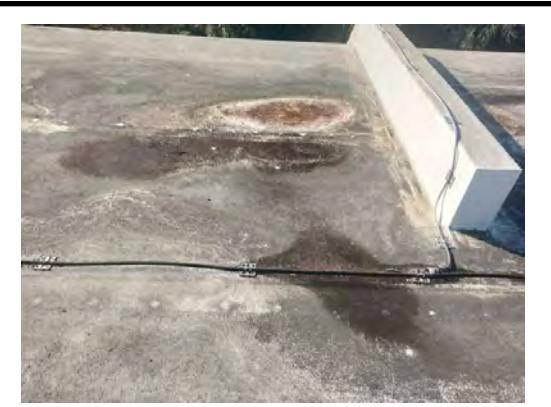
40 Observed Ponding Water - Flat Roof Building A

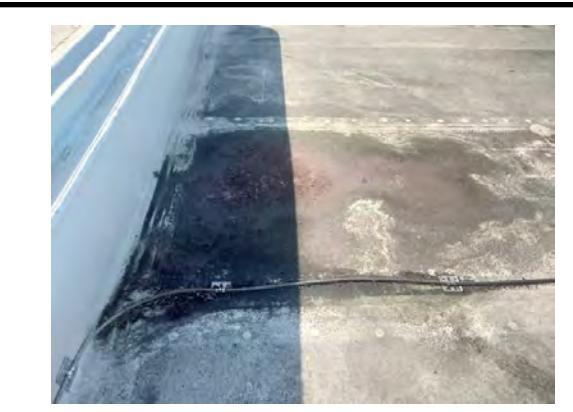
47 Observed Staining - Flat Roof Building A

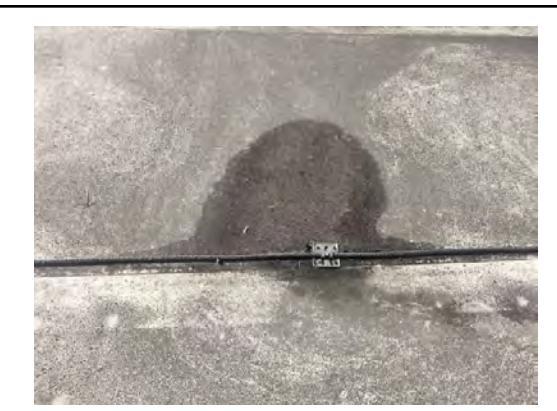
42 Observed Ponding Water - Flat Roof Building A

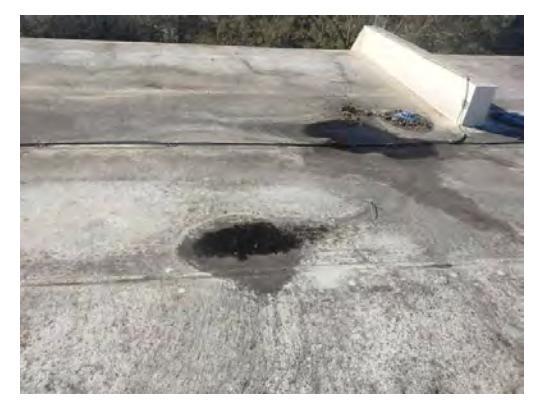
44 Observed Ponding Water - Flat Roof Building A

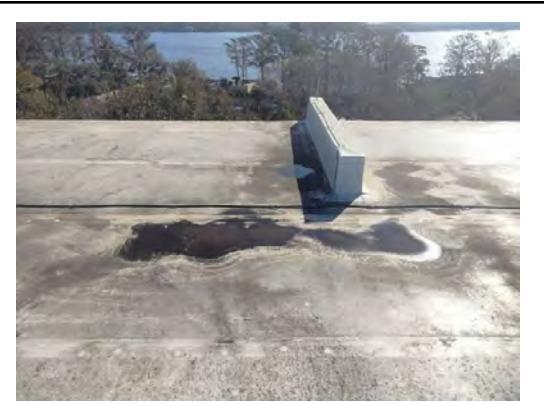
49 Observed Staining - Flat Roof Building A

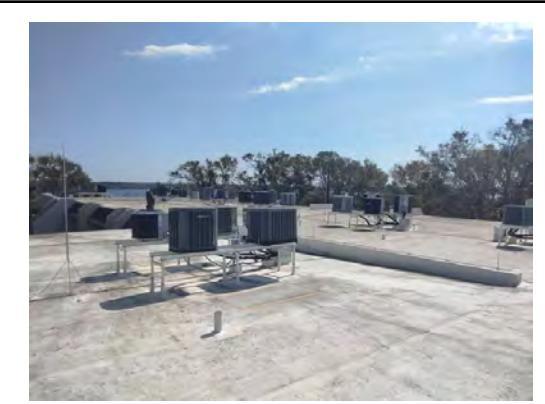
52 Observed Staining - Flat Roof Building A

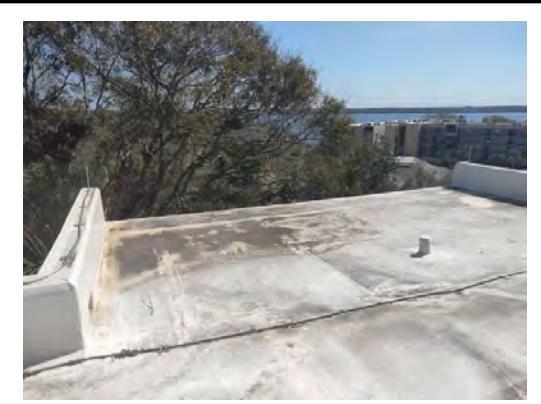
63 Observed Ponding Water and Debris - Flat Roof Building A

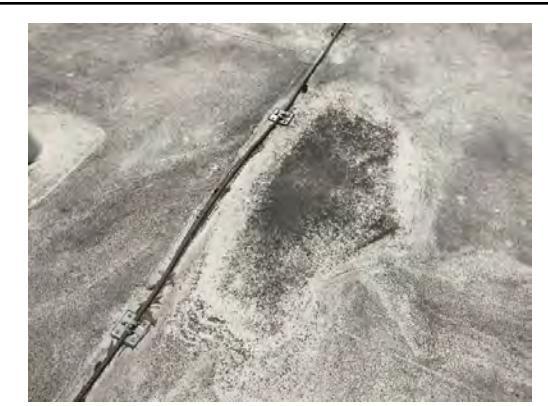
58 Observed Staining - Flat Roof Building B

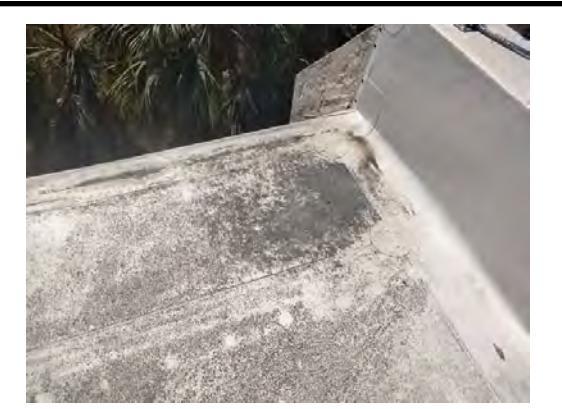
62 Observed Staining and Debris - Flat Roof Building B

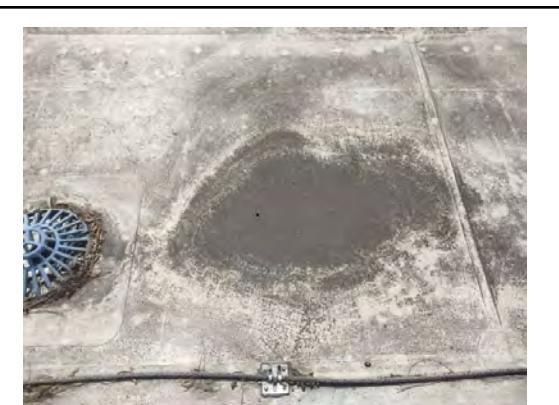
65 Observed Staining - Flat Roof Building B

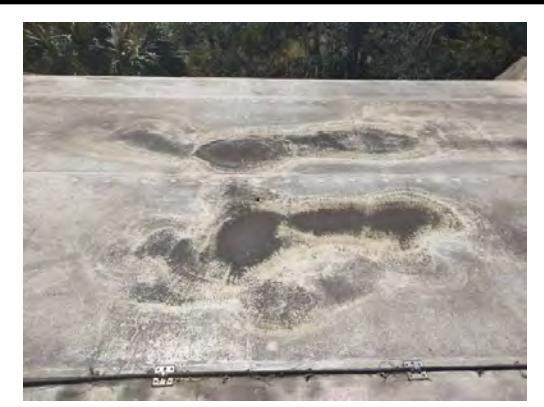
66 Observed Ponding Water - Flat Roof Building A

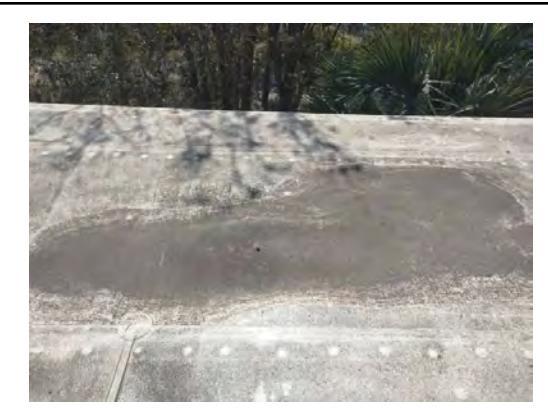
68 Observed Staining - Flat Roof Building B

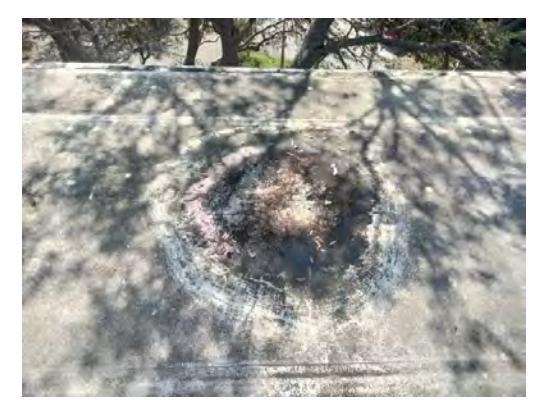
70 Observed Ponding Water and Debris - Flat Roof Building A

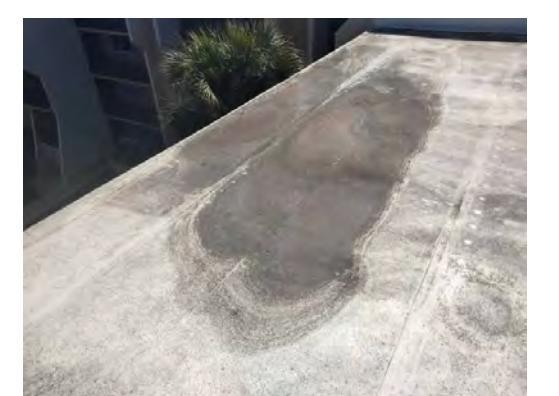
73 Observed Ponding Water - Flat Roof Building A

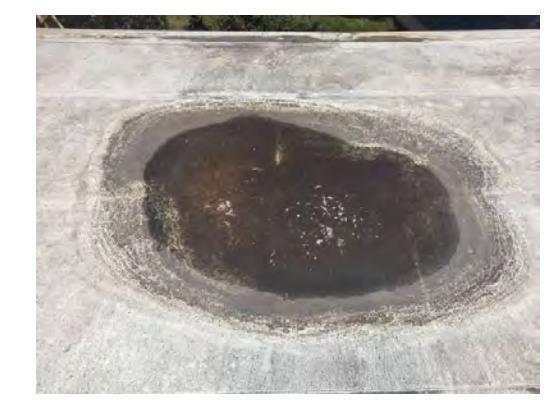
74 Observed Ponding Water - Flat Roof Building A

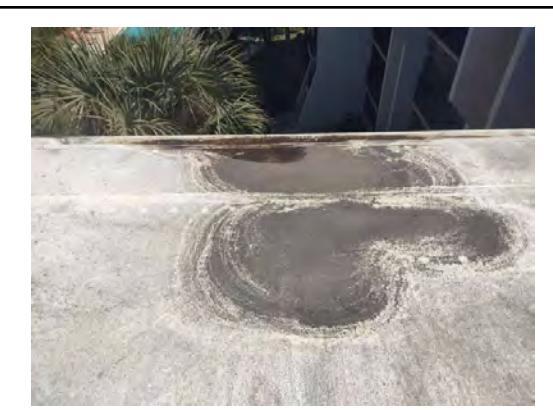
76 Observed Ponding Water - Flat Roof Building A

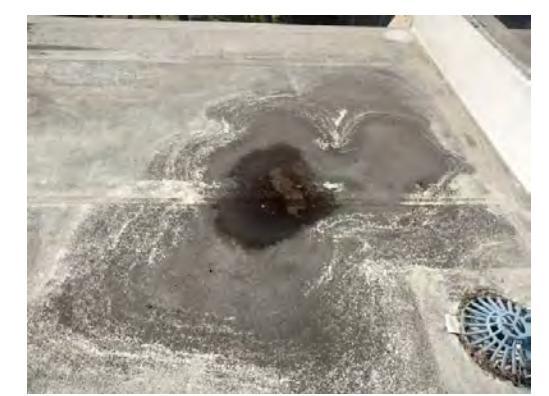
• Ceiling stains and moisture damage were reported and observed in units 407, 408, and 409.

78 Ponding Water - Building A, Unit 407

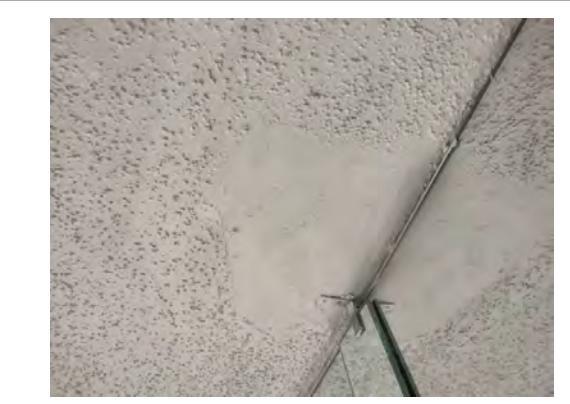
82 Unit 407 - Ceiling Damage (Lanai)

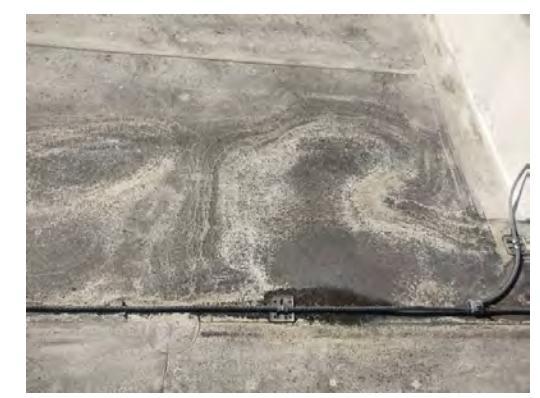
86 Staining - Building A, Unit 408

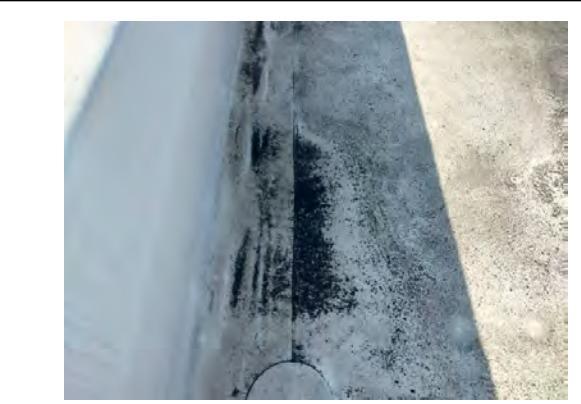
88 Staining - Building A, Unit 408

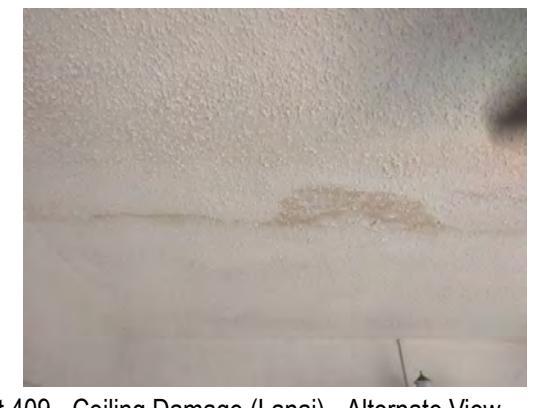
95 Unit 409 - Ceiling Damage (Lanai) - Alternate View

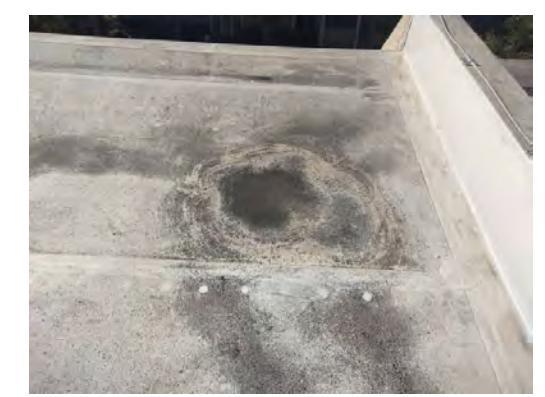
90 Staining - Building A, Unit 409

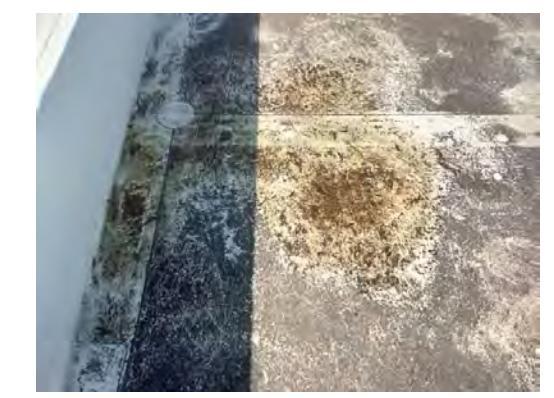
92 Ponding Water - Building A, Unit 409

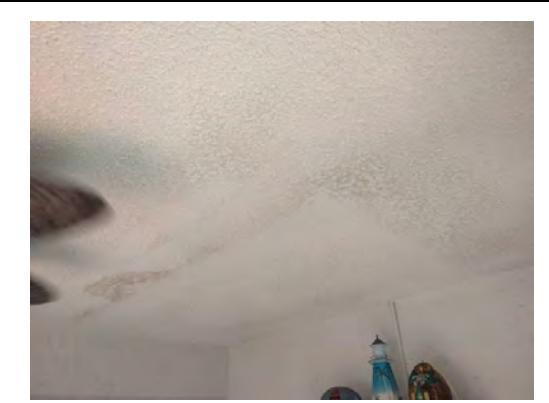
94 Unit 409 - Ceiling Damage (Lanai)

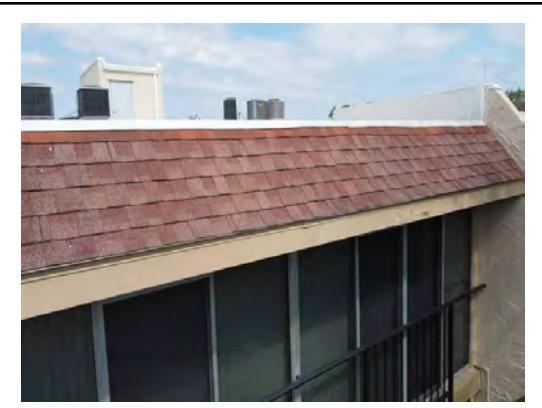
- Bowing was observed to the several planes of the mansard roof of both buildings.
- Sections of wood rot, peeling paint, and degradation were noted to sections of the fascia and soffit of both buildings.

Excessive water can seep under the shingles, penetrating the roof deck and causing leaks inside the structure. Persistent moisture can cause the underlying sheathing, framing, and fascia to rot, weakening the structural integrity of the mansard.

108 Observed Bowing - Mansard Roof Building A

Insufficient or mispositioned drains, scuppers, or gutters has led to uncontrolled runoff that has overwhelmed the building's exterior. Additional internal drains, scuppers, or gutters are recommended to facilitate proper storm water drainage. Scuppers, internal drains, and gutters should be properly sized and positioned to handle heavy rain events. Water collected in the scuppers or gutters should be redirected from the roofs edge via a downspout and diverted at least 2 feet away from the base of the foundation with the use of extensions. Gutters and downspouts require maintenance, it is advisable to inspect the gutters monthly during rains for proper flow.

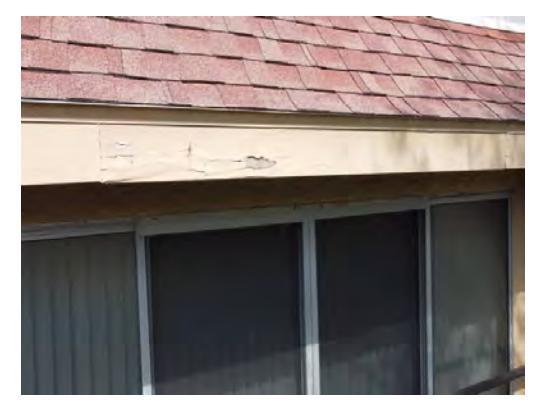
110 Wood Rot and Peeling Paint - Mansard Roof Building A

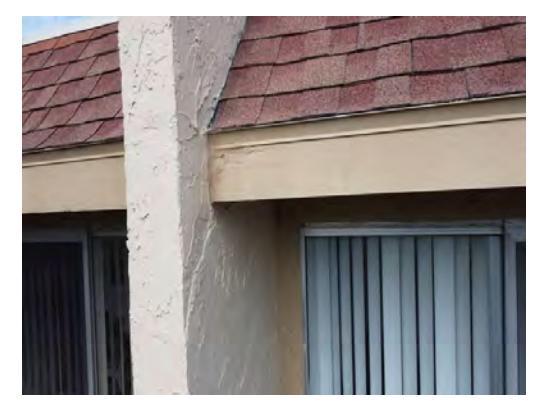
112 Wood Rot and Peeling Paint - Mansard Roof Building A

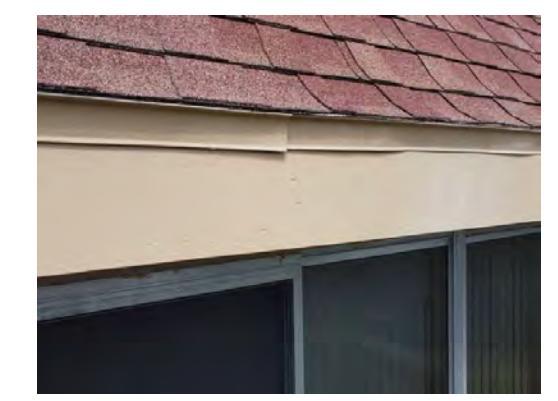
114 Open Drip Edge Connection - Mansard Roof Building A

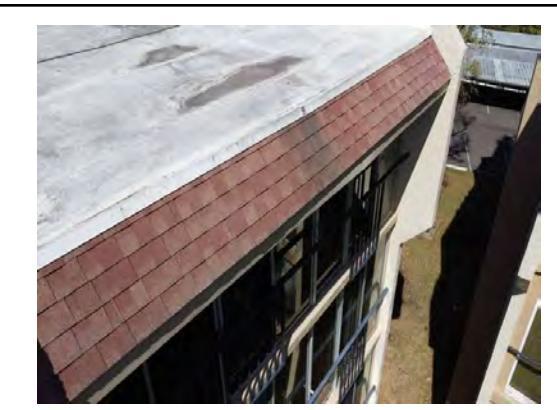
- 2. Beryl understands that following the reroof in 2022, there has been uncontrolled stormwater runoff from both roofs. When a flat roof lacks proper drainage, heavy rain can spill over the edges. This condition was confirmed by photographs and videos provided by the client.
  - Streaking and discoloration was observed on several of the shingled mansard roof sections of both buildings.

Uncontrolled stormwater runoff from a flat roof onto a shingled mansard can cause significant damage over time. Continuous water flow can erode the protective granules on asphalt shingles, making them brittle and more susceptible to cracking, curling, and premature failure.

116 Observed Staining - Mansard Roof Building B

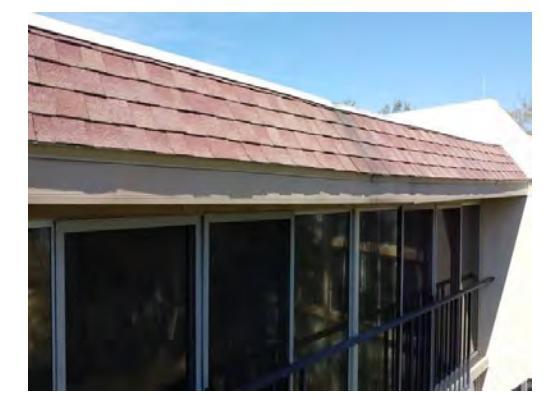
**118** Observed Bowing - Mansard Roof Building B

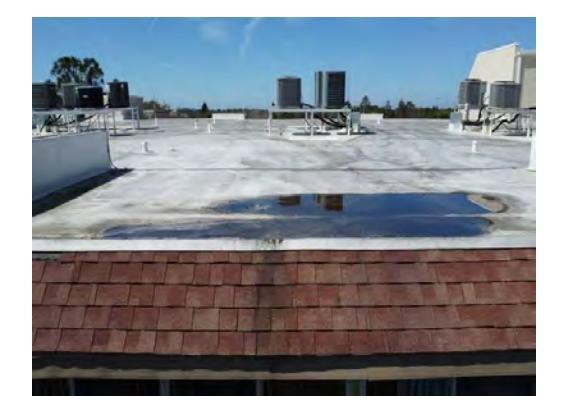
120 Observed Staining - Mansard Roof Building B

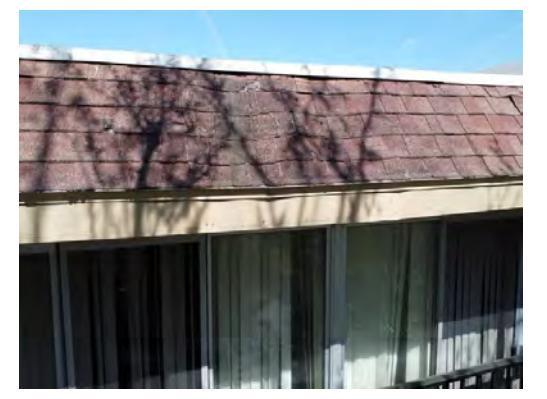
121 Observed Bowing and Staining - Mansard Roof Building B

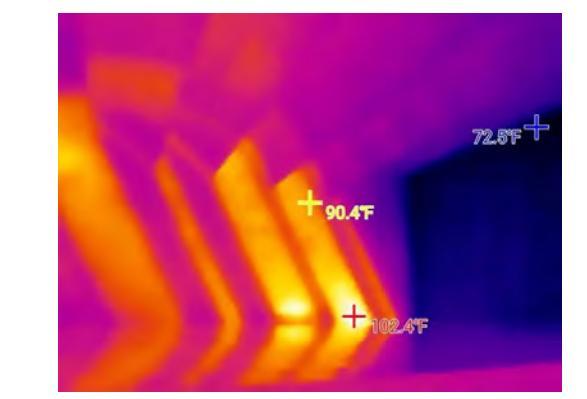
• Water intrusion around and under the lanai sliding doors was reported to occur during significant rain events. Evidence of intrusion was observed in the form of staining, peeling paint, biological growth, and buckling of the finished flooring in units 209, 212, 218, 312, and 318.

Improperly directed runoff causes moisture buildup and can seep into window frames, door thresholds, or exterior wall cracks. Excessive runoff can create hydrostatic pressure against walls, pushing water into seams and openings.

130 Unit 212 - Thermal Imaging (Flooring)

We recommend sealing all exterior wall cracks, as well as around door and window penetrations, with an elastomeric masonry patching compound, and the buildings should be repainted. Some of the cracks may require widening/cleaning with minor repairs/patching. Elastomeric patching and paint will allow for minimal future movements and should be less likely to cause a reopening crack in the future.

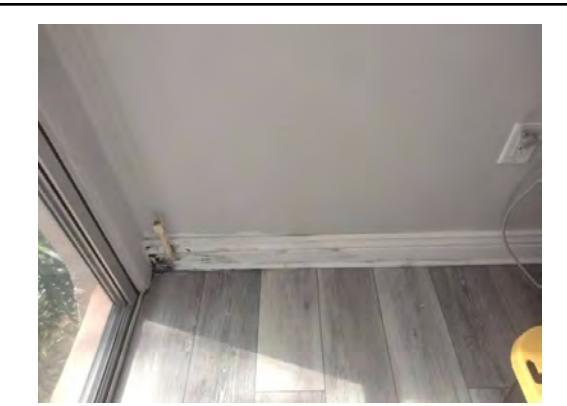
132 Unit 218 - Observed Biological Growth (Wall)

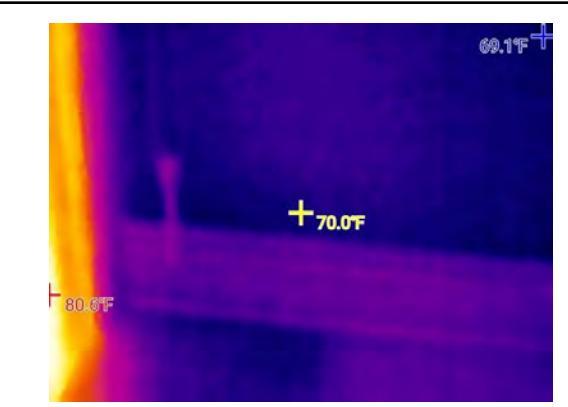
134 Unit 218 - Thermal Imaging (Wall)

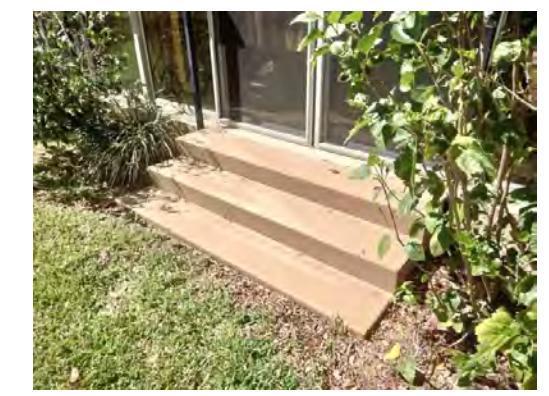
• The sliding glass doors on the lanai of unit 114 are binding and do not open properly.

When the soil is saturated, the resulting bearing capacity is significantly reduced, which allows the potential for settlement. High runoff volumes with excessive water near the foundation can also wash away soil around the building. As a result, differential settlement of the foundation has caused the door frame to be misaligned. Furthermore, prolonged exposure to moisture can cause metal components (rollers, tracks, or locking mechanisms) to rust, leading to sticking or jamming.

174 Unit 114 - Erosion at Foundation
