Windstorm Mitigation Report

Lake Tarpon Sail And Tennis Club III Condominium

Tarpon Springs, FL

As of 2/16/2022 | FPAT File# MUD2217151

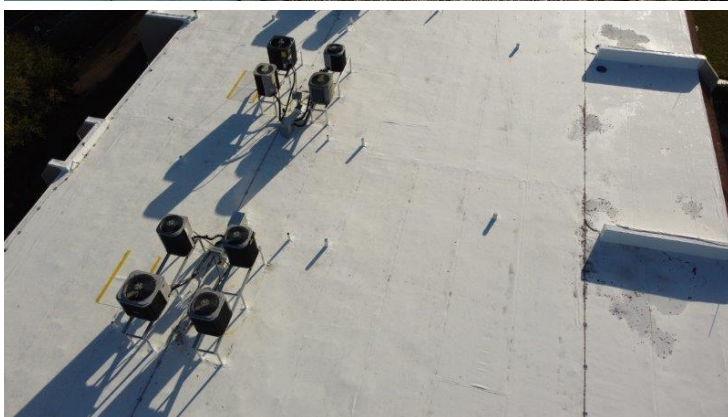
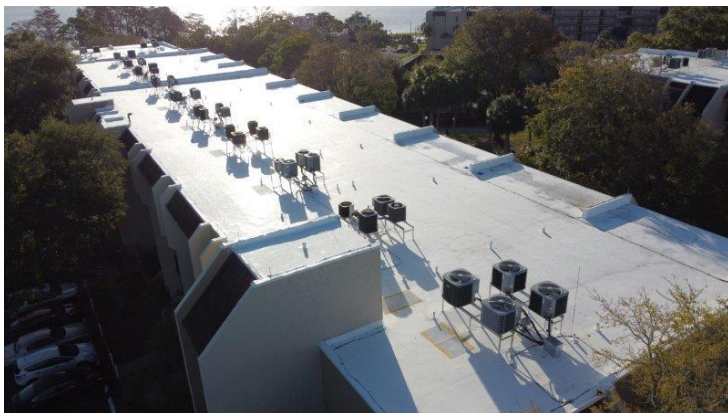
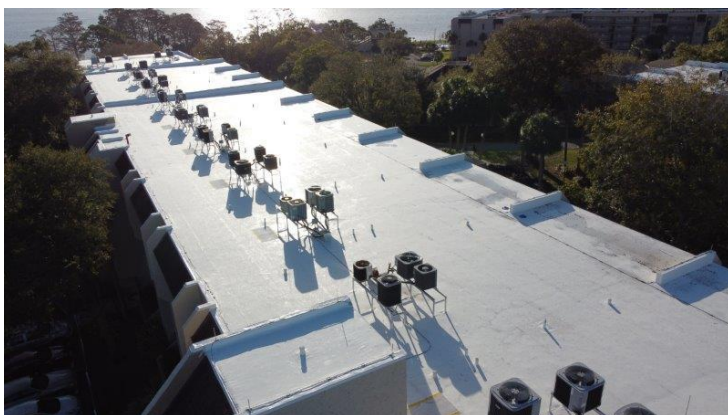
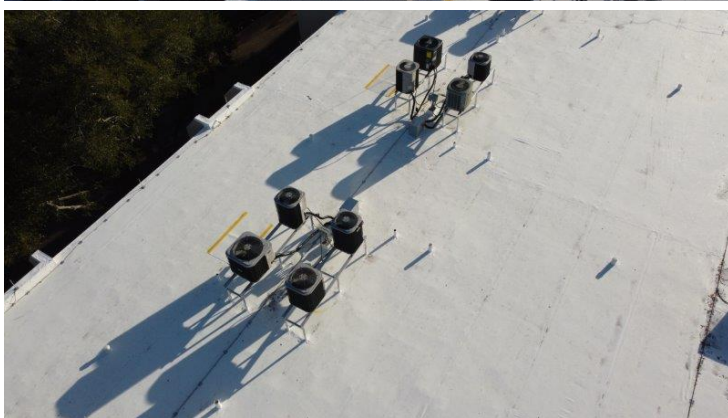
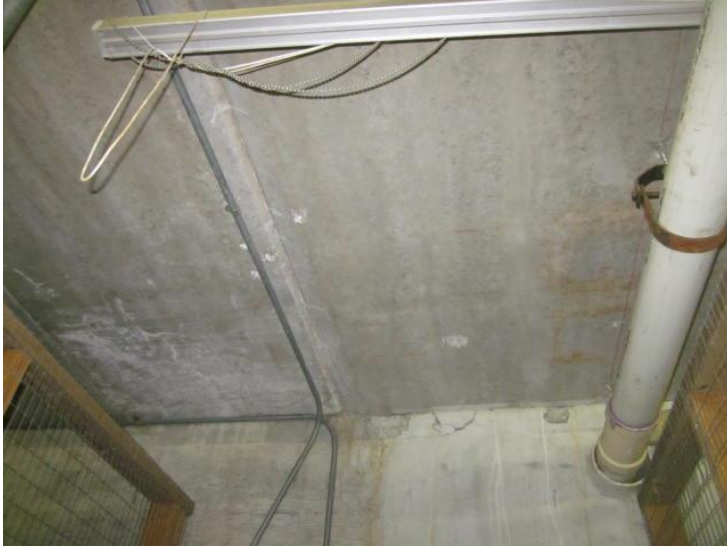
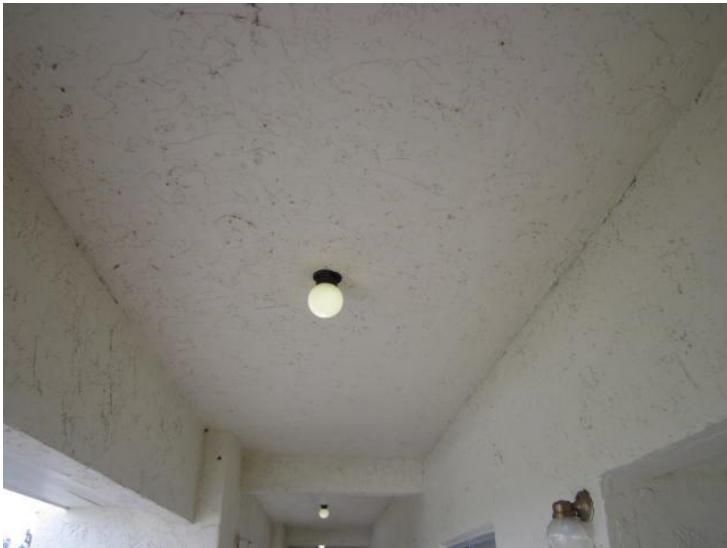
Roof Construction

- 3. Roof Deck Attachment:** **Reinforced Concrete Roof Deck**
Comments: Inspection verified a roof structure composed of cast-in-place or pre-cast structural concrete designed to be self-supporting and integrally attached to the wall / support system.

- 4. Roof to Wall Attachment:** **Structural**
Comments: Inspection verified a roof structure composed of cast-in-place or pre-cast structural concrete designed to be self-supporting and integrally attached to the wall / support system.

- 5. Roof Geometry:** **Flat Roof**
Comments: Inspection verified flat roof shape, refer to attached photographs.
- 6. SWR:** **No**
Comments: SWR does not apply to reinforced concrete roof decks.

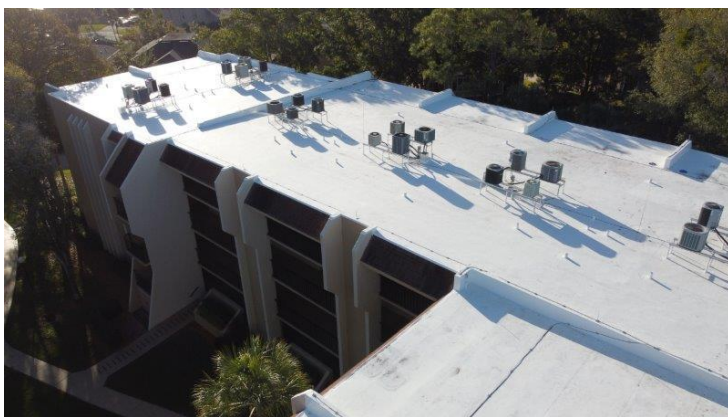
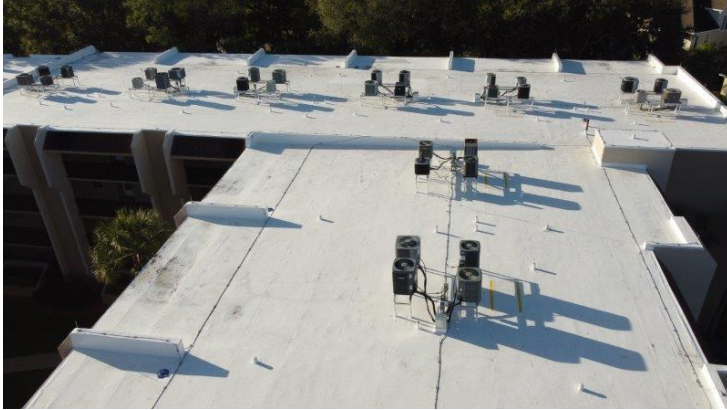
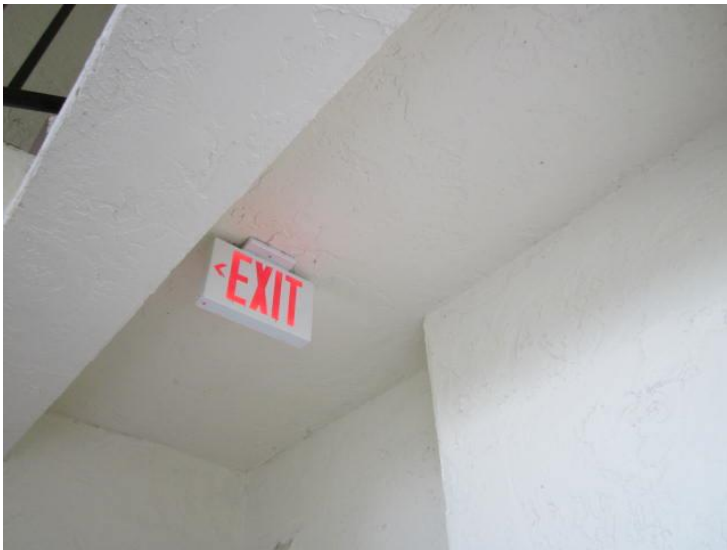
Roof Construction

- 5. Roof Geometry:** **Flat Roof**
Comments: Inspection verified flat roof shape, refer to attached photographs.
- 6. SWR:** **No**
Comments: SWR does not apply to reinforced concrete roof decks.

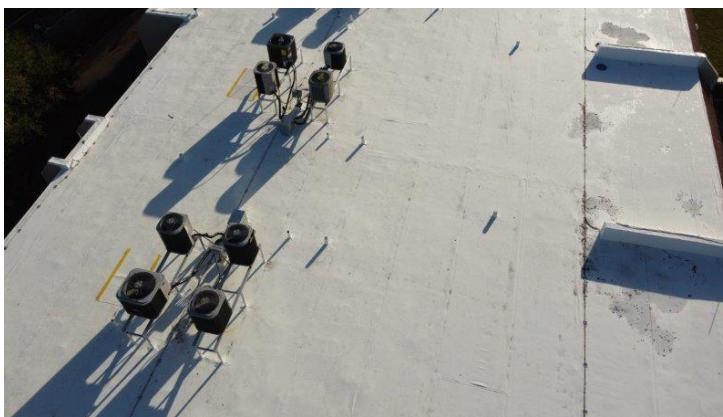
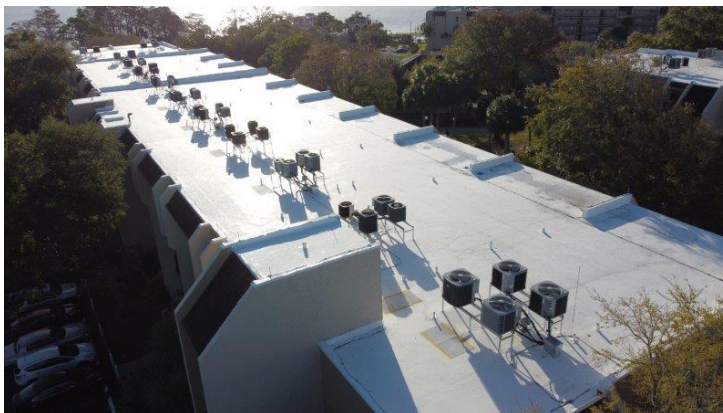
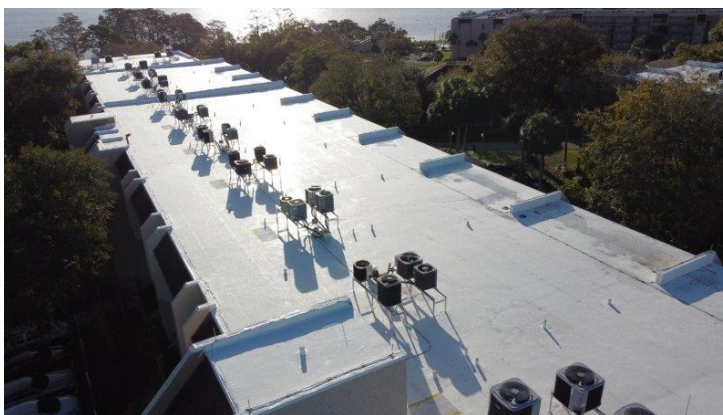
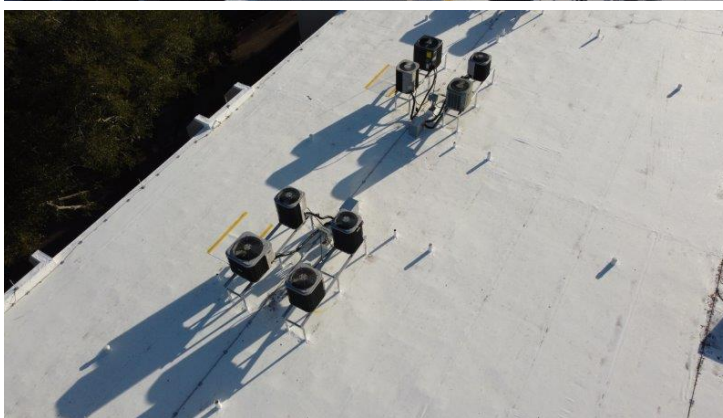
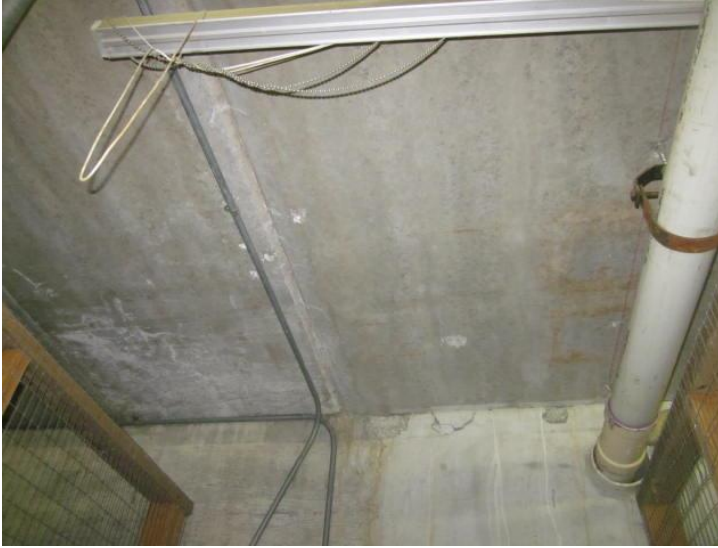
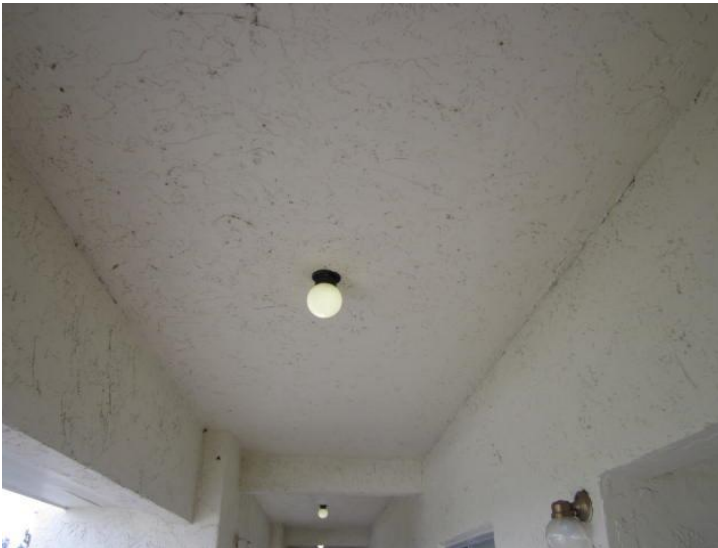
Roof Construction

- 1. Roof Covering:** **FBC Equivalent**
Comments: The roof covering was replaced in 2021. The roof permit was confirmed and the permit number is 21-00002675. This roof was verified as meeting the building code requirements outlined on the mitigation affidavit.
- 2. Roof Deck Attachment:** **Reinforced Concrete Roof Deck**
Comments: Inspection verified a roof structure composed of cast-in-place or pre-cast structural concrete designed to be self-supporting and integrally attached to the wall / support system.
- 3. SWR:** **No**
Comments: SWR does not apply to reinforced concrete roof decks.
- 4. Opening Protection:** **None or Some Glazed Openings**
Comments: No opening protection verified at the time of inspection

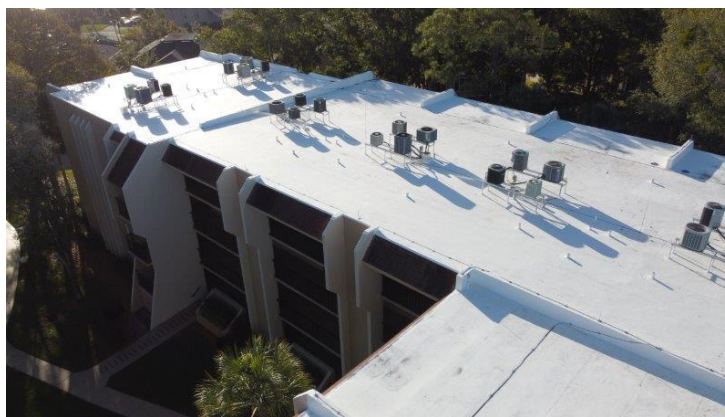
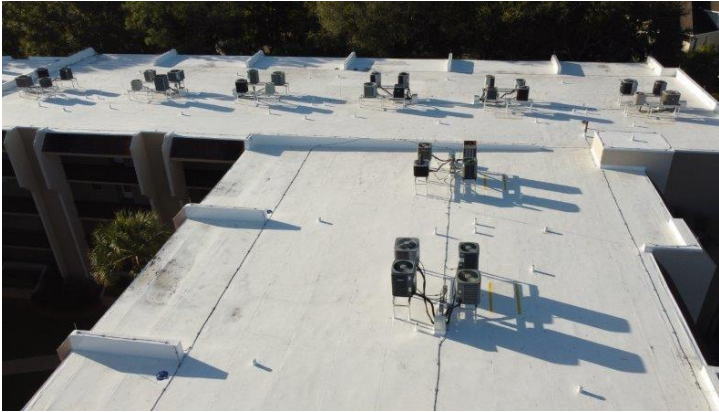
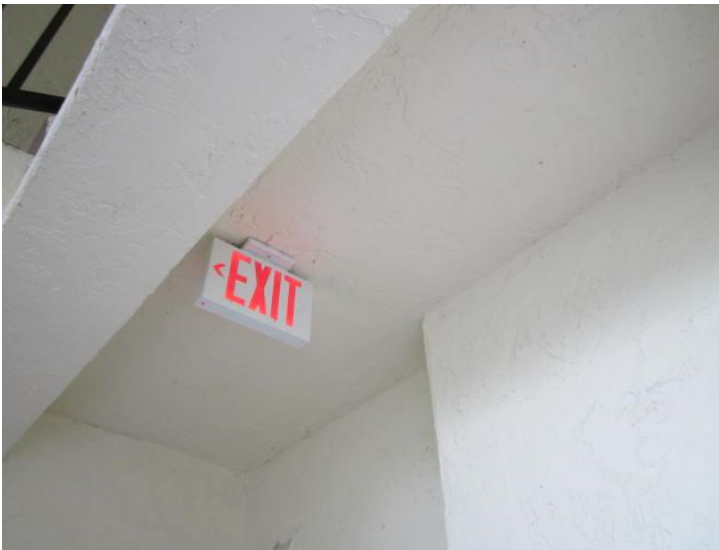
Roof Construction

- 1. Roof Covering:** **FBC Equivalent**
Comments: The roof covering was replaced in 2021. The roof permit was confirmed and the permit number is 21-00002675. This roof was verified as meeting the building code requirements outlined on the mitigation affidavit.
- 2. Roof Deck Attachment:** **Reinforced Concrete Roof Deck**
Comments: Inspection verified a roof structure composed of cast-in-place or pre-cast structural concrete designed to be self-supporting and integrally attached to the wall / support system.
- 3. SWR:** **No**
Comments: SWR does not apply to reinforced concrete roof decks.
- 4. Opening Protection:** **None or Some Glazed Openings**
Comments: No opening protection verified at the time of inspection
