To:Lake Tarpon Sail and Tennis Club IIIFrom:Leo Cannyn, PMP, P.E., Principal Project ManagerSubject:90 S Highland Ave, Tarpon Springs, FL 34689 Engineering AffidavitDate:2/14/2025

Beryl Engineering & Inspection, LLC ("Beryl") was retained by Lake Tarpon Sail and Tennis Club III with regards to inspection located at 90 S Highland Ave, Tarpon Springs, FL 34689. According to the Pinellas County Property Appraiser Website, the buildings were built in 1983. The structural systems are consistent with a Slab on Grade foundation with Concrete Masonry Unit (CMU) walls clad in Stucco veneer. The roof structure is consistent with a predominantly Flat roof design covered with TPO. There is a secondary accent Mansard roof covered with Dimensional Shingles. Beryl was asked to inspect the roofs of buildings A and B, as well as the interior of the units experiencing water intrusion issues at the sliding glass doors.

The primary purpose of this letter is for Beryl, as Engineer, to certify that at the time of their review on 2/14/2025 we found that the roofs of buildings A and B were replaced in 2022. It was reported that the roofer explained that the existing internal perimeter drain was no longe

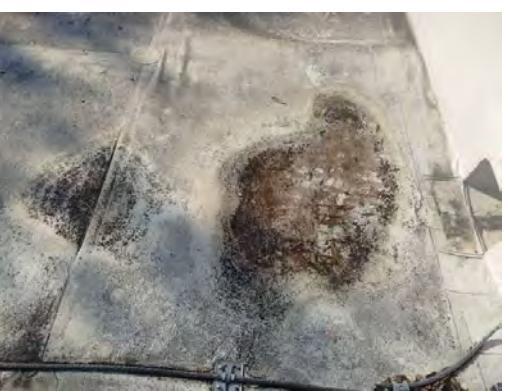
1. Several dark areas and low spots were observed on the TPO roof covering of both buildings. Typically, dark spots or staining on the roofing material are the result frequent water pooling.

Prolonged exposure to ponding water can degrade the TPO membrane, causing discoloration, leaks, and premature failure. Standing water also increases the load on the roof, which can lead to sagging or collapse.

29 Observed Ponding Water - Flat Roof Building A

Additionally, it would be prudent to ensure the roof has at least 1/4 inch per foot slope to direct water toward drains or scuppers. If the slope is insufficient or there are low spots, water can pond and seep into the roofing membrane. The use of insulation boards to create a slope in low areas can repair low spots or depressions that hold water. Tapered insulation is a cost-effective way to ensure proper roof slope and improve drainage on an existing flat roof.

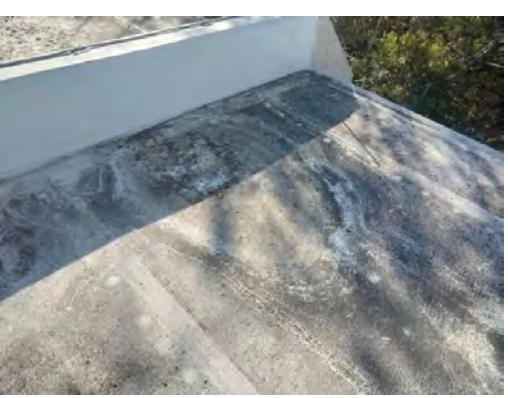
- Water evaporation leaves behind dirt, dust, and organic matter, creating dark stains in areas where water has pooled.
- Standing water was also observed, which promotes the growth of algae, mold, or mildew, and can appear as dark spots or streaks.

31 Observed Staining - Flat Roof Building A

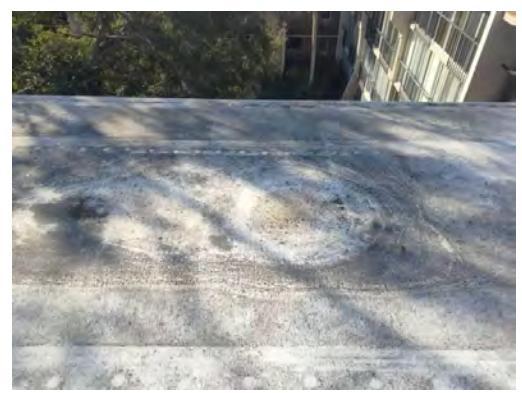
30 Observed Staining - Flat Roof Building A

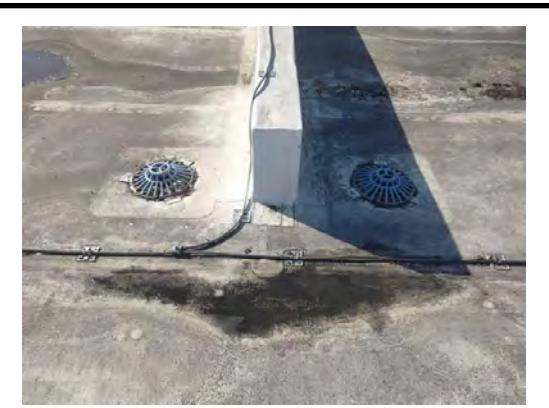
33 Observed Ponding Water - Flat Roof Building A

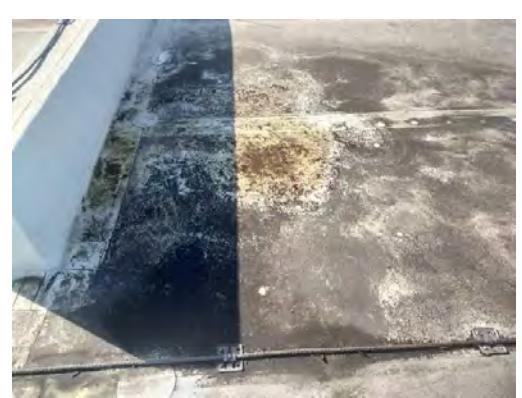
37 Observed Staining - Flat Roof Building A

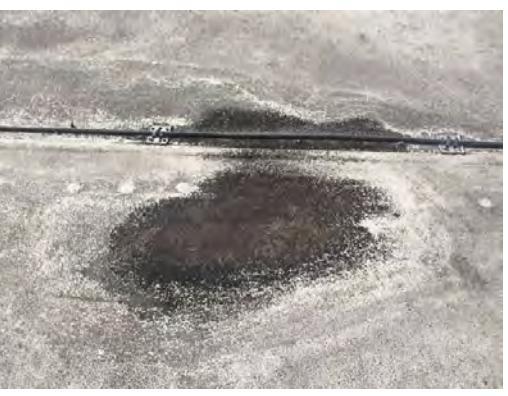
39 Observed Ponding Water - Flat Roof Building A

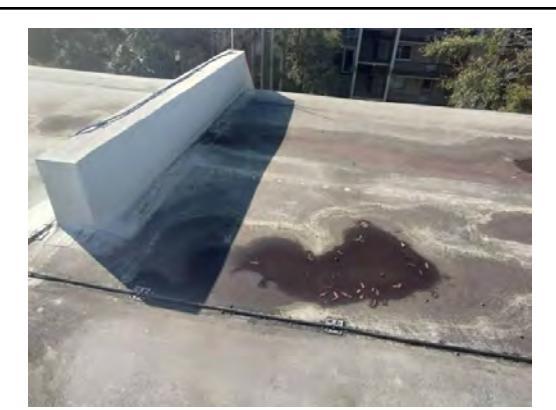
36 Observed Ponding Water - Flat Roof Building A

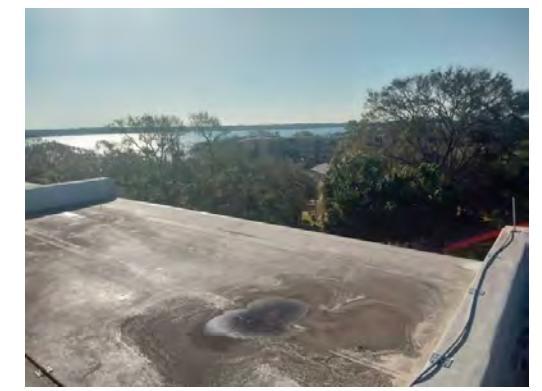
38 Observed Ponding Water - Flat Roof Building A

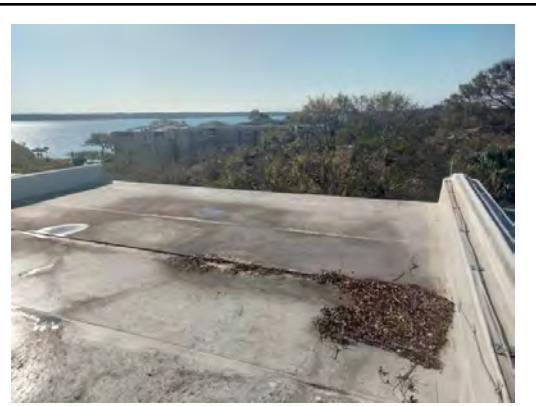
43 Observed Debris - Flat Roof Building A

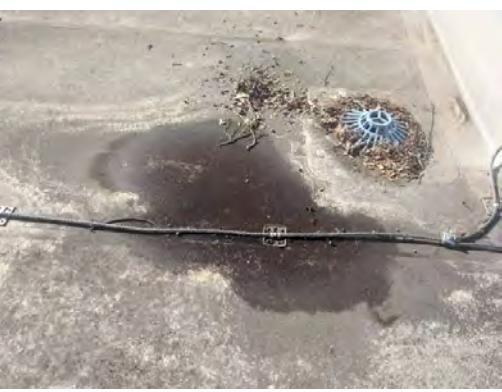
45 Observed Ponding Water - Flat Roof Building A

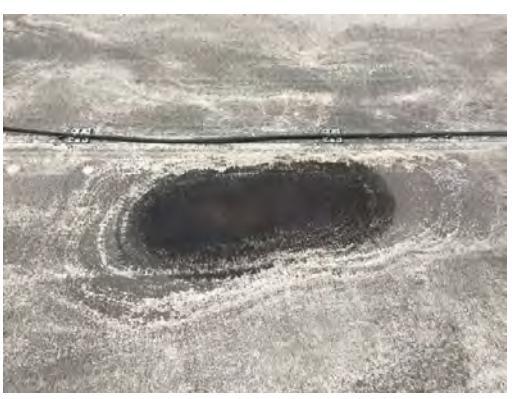
47 Observed Staining - Flat Roof Building A

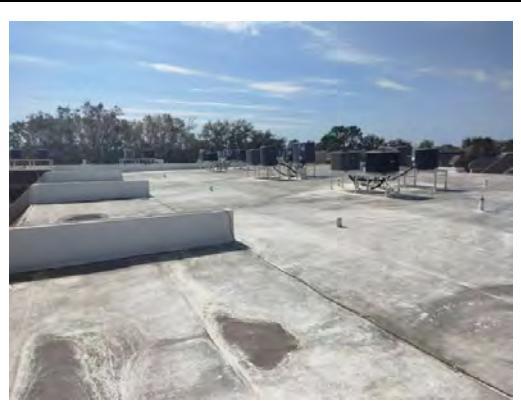
53 Flat Roof Overview - Building B

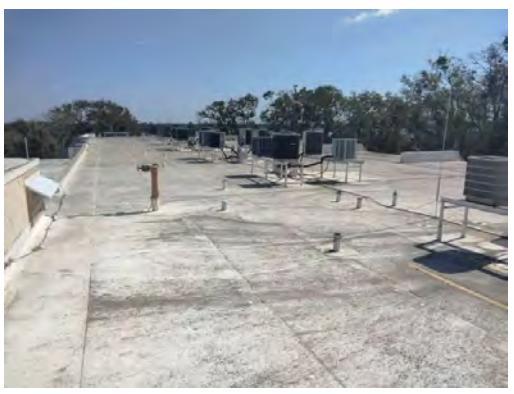
55 Flat Roof Overview - Building B

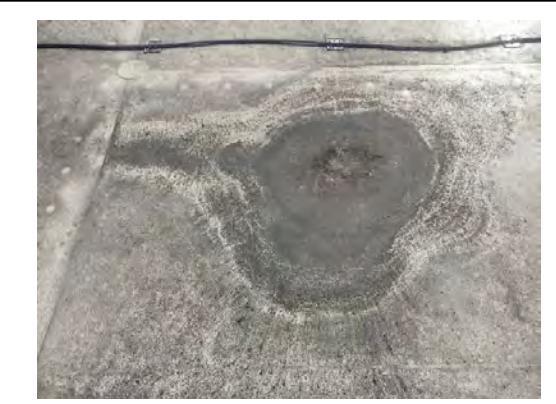
52 Observed Staining - Flat Roof Building A

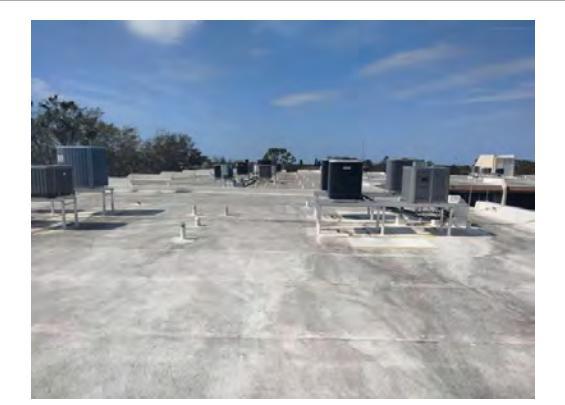
56 Flat Roof Overview - Building B

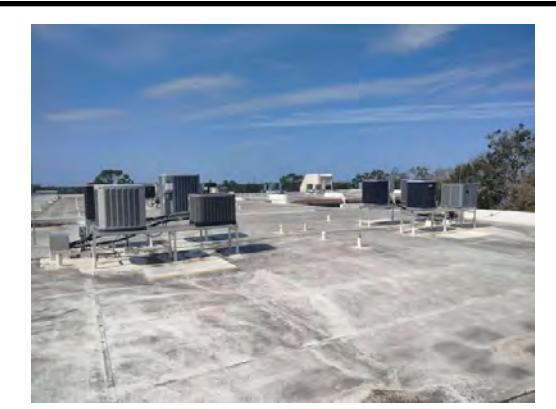
57 Flat Roof Overview - Building B

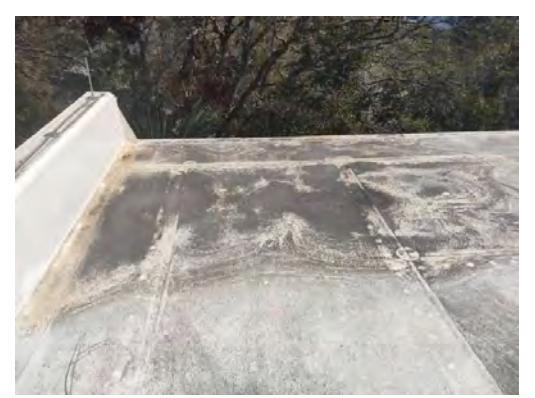
59 Observed Staining - Flat Roof Building B

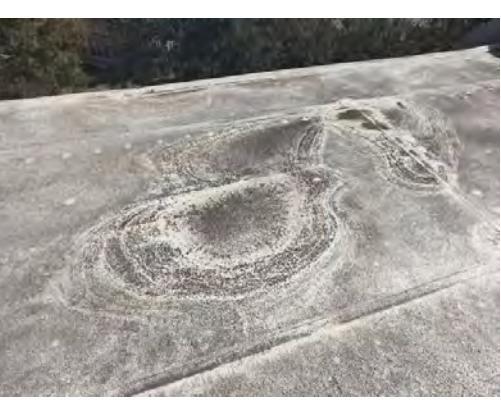
61 Observed Staining - Flat Roof Building B

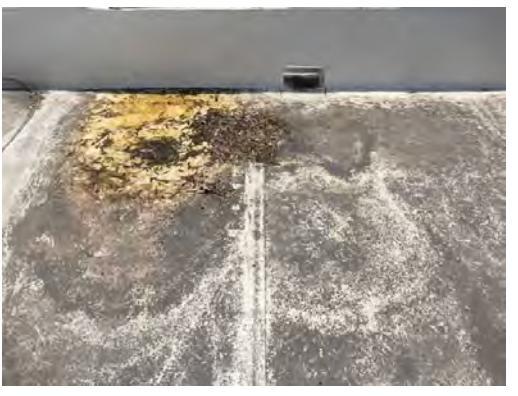
63 Observed Ponding Water and Debris - Flat Roof Building A

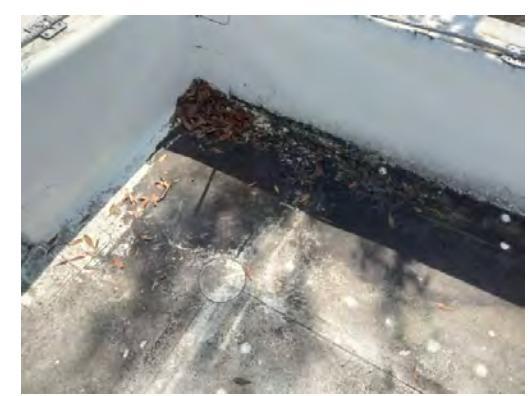
62 Observed Staining and Debris - Flat Roof Building B

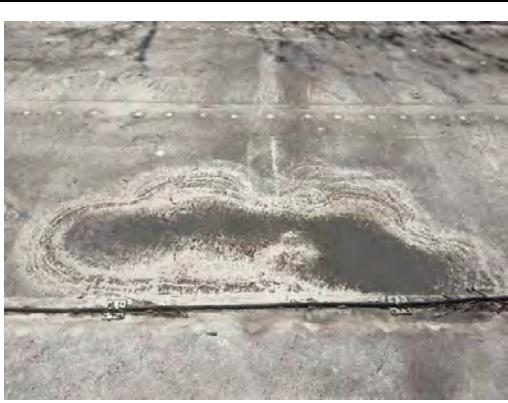
69 Observed Staining - Flat Roof Building B

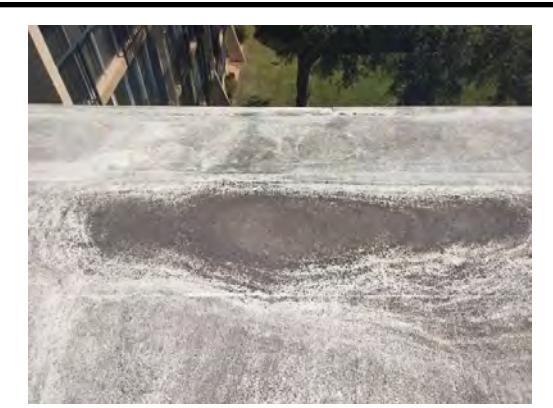
73 Observed Ponding Water - Flat Roof Building A

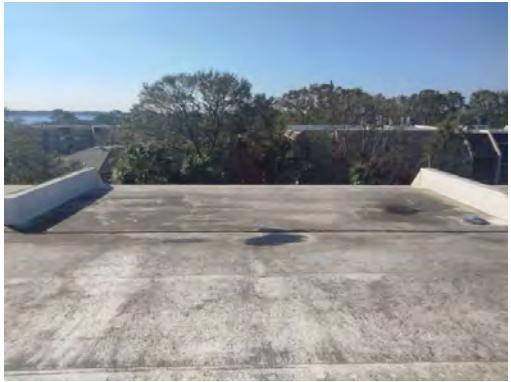
77 Flat Roof Overview - Building A, Unit 407

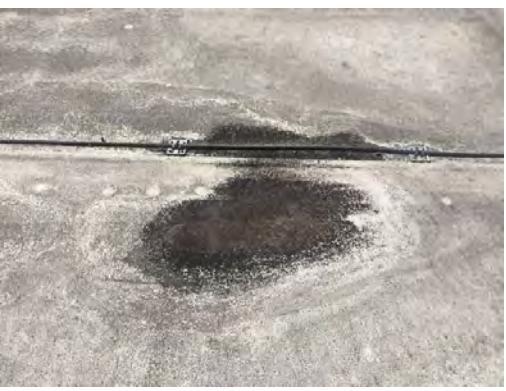
79 Ponding Water - Building A, Unit 407

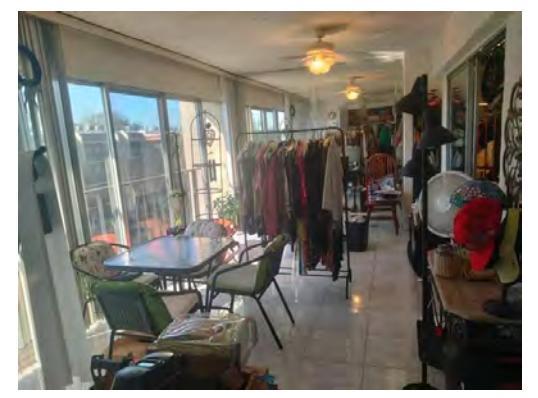
81 Unit 407 - Lanai Overview

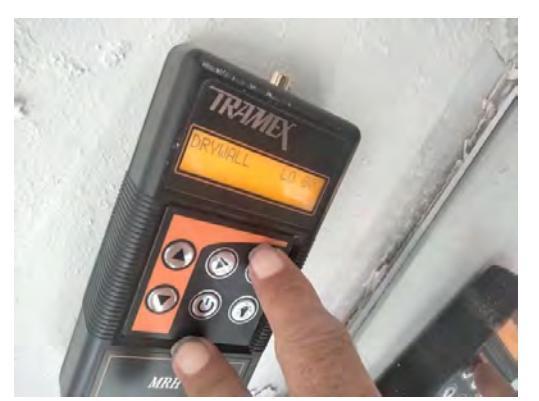
83 Unit 407 - Moisture Reading (Low)

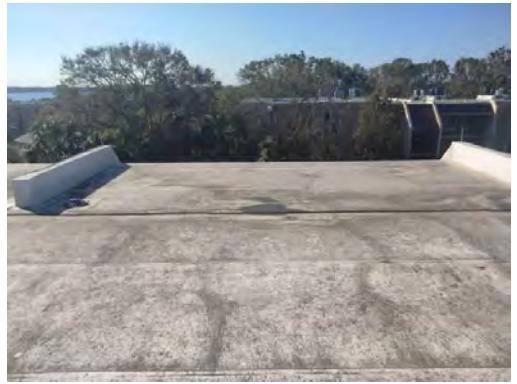
85 Flat Roof Overview - Building A, Unit 408

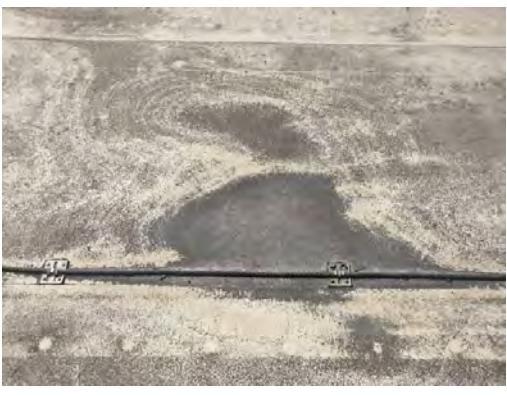
87 Staining - Building A, Unit 408

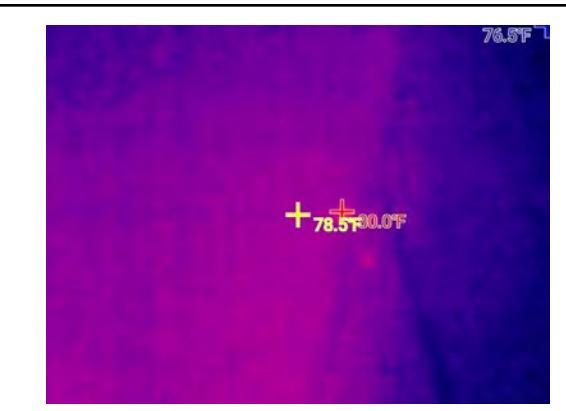
84 Unit 407 - Thermal Imaging

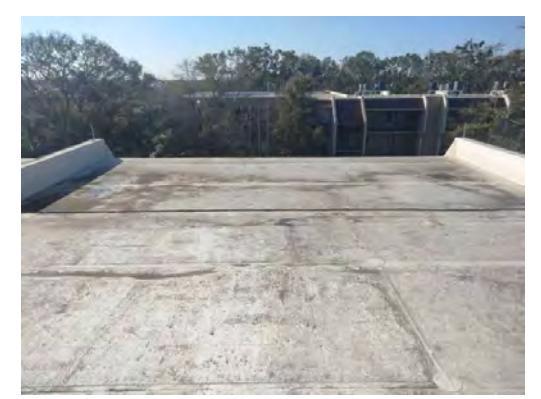
89 Flat Roof Overview - Building A, Unit 409

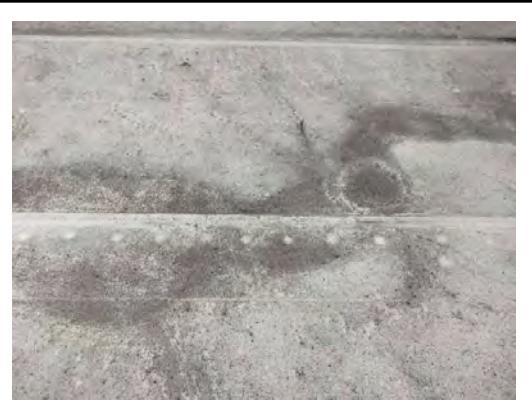
91 Staining - Building A, Unit 409

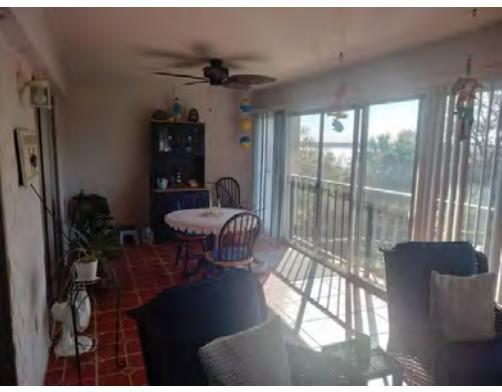
93 Unit 407 - Lanai Overview

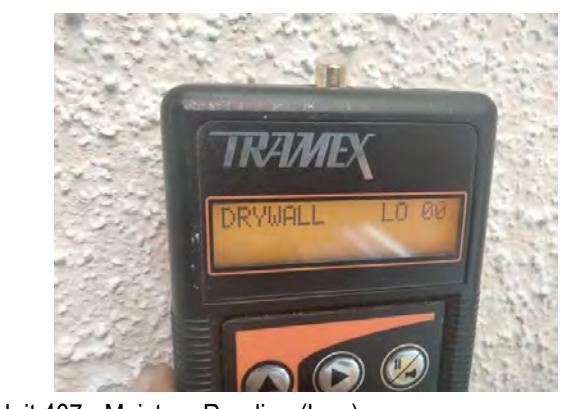
96 Unit 407 - Moisture Reading (Low)

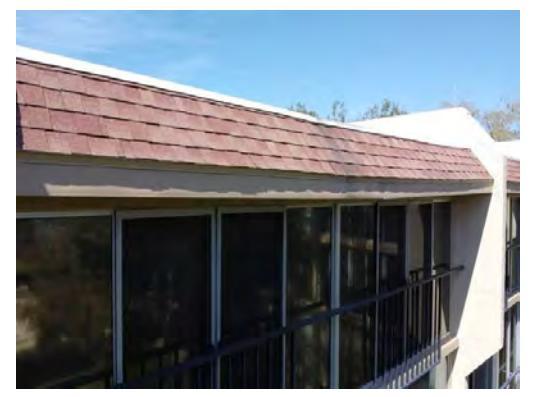
105 Mansard Roof Overview - Building B

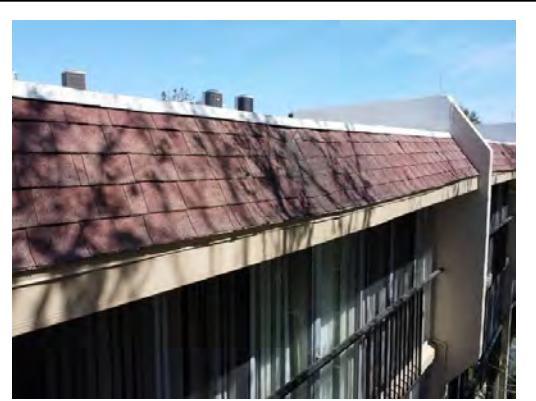
107 Mansard Roof Overview - Building B

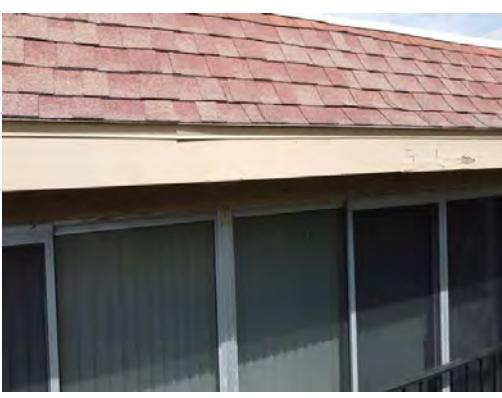
109 Open Drip Edge Connection - Mansard Roof Building A

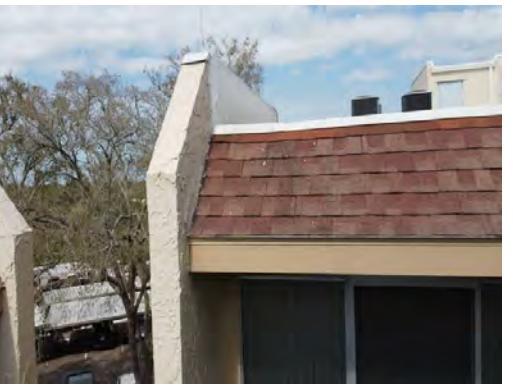
111 Observed Staining - Mansard Roof Building A

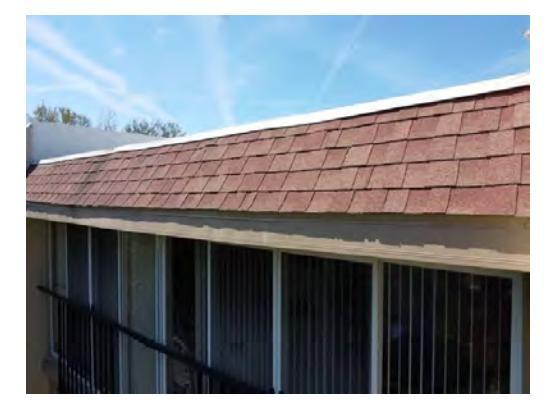
106 Mansard Roof Overview - Building B

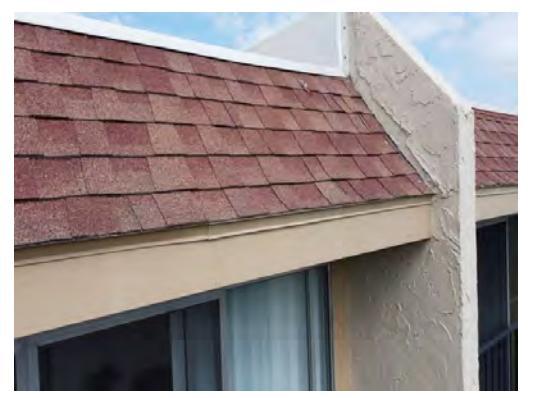
113 Observed Bowing - Mansard Roof Building A

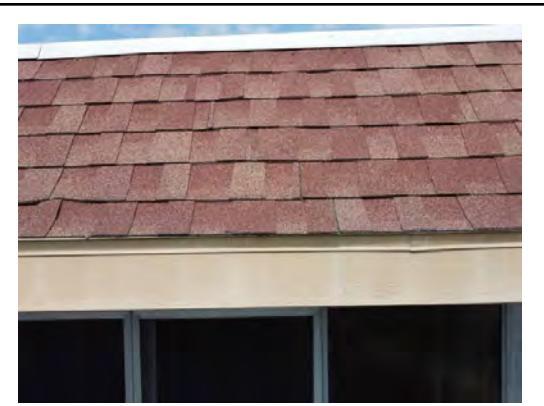
115 Observed Bowing - Mansard Roof Building A

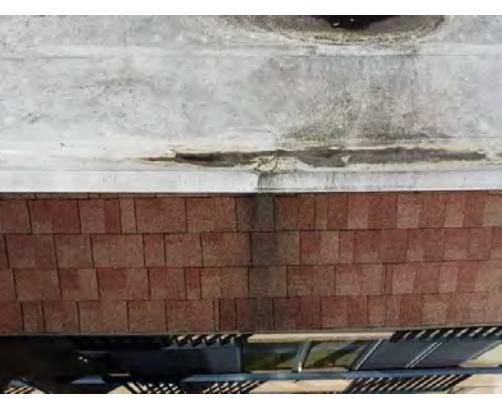
117 Observed Staining - Mansard Roof Building B

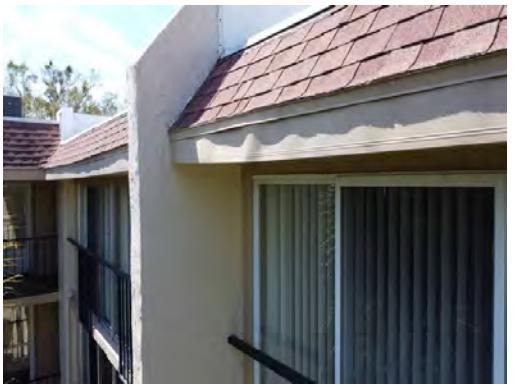
119 Fascia Damage - Mansard Roof Building B

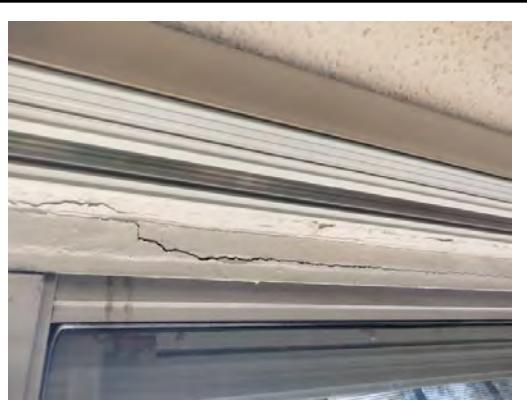
123 Unit 209 - Ceiling Damage (Lanai)

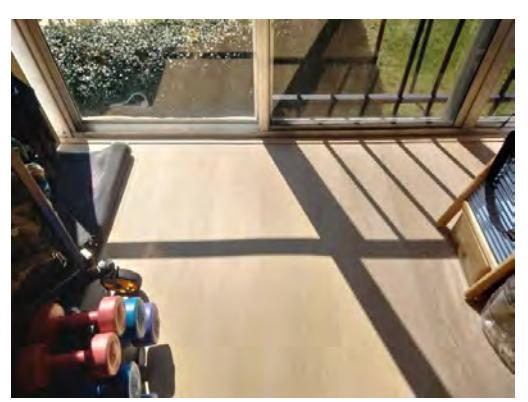
125 Unit 209 - Flooring Damage (Lanai)

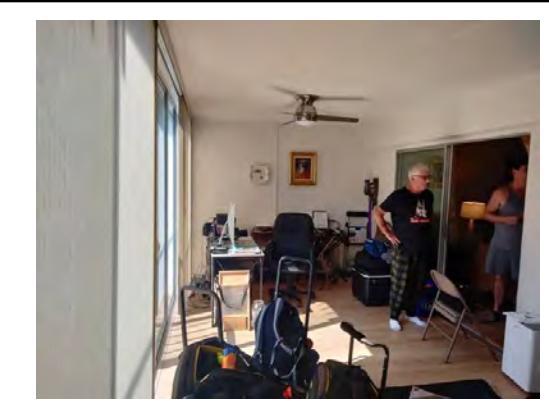
122 Unit 209 - Lanai Overview

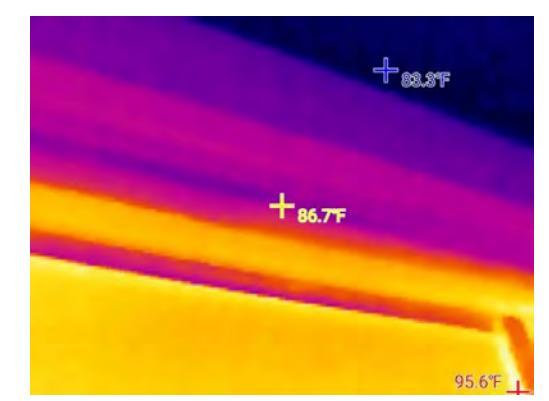
124 Unit 209 - Thermal Imaging (Top of Sliding Glass Door)

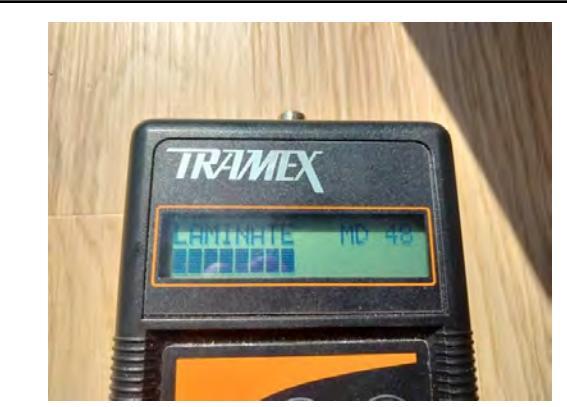
126 Unit 209 - Moisture Reading (Medium)

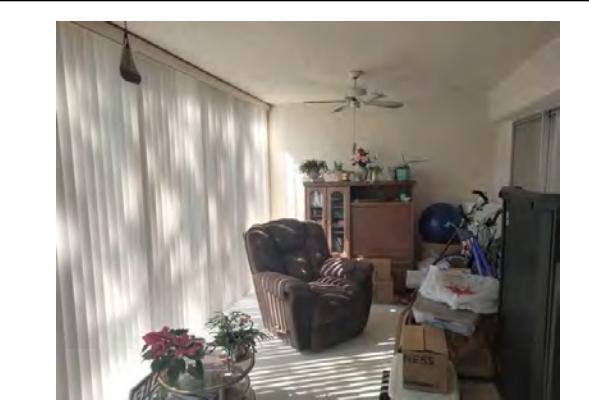
128 Unit 212 - Lanai Overview

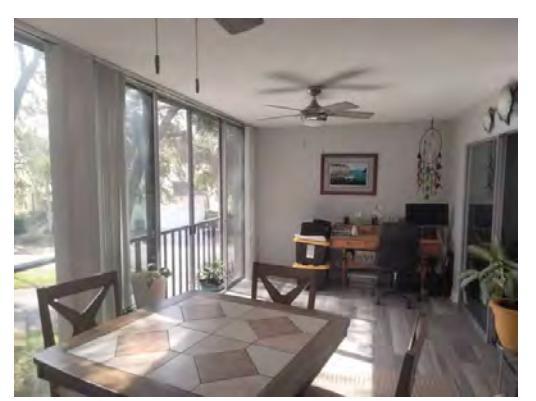
131 Unit 218 - Lanai Overview

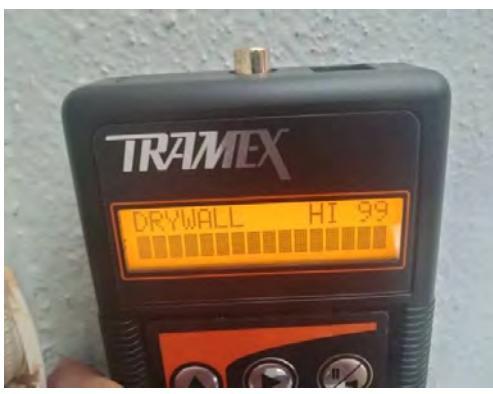
133 Unit 218 - Moisture Reading (High)

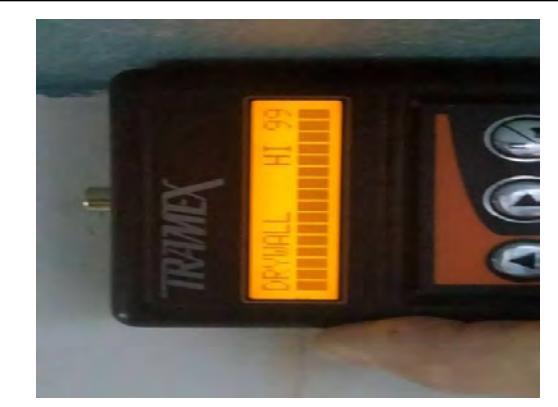
170 Unit 302 - Moisture Reading (High)

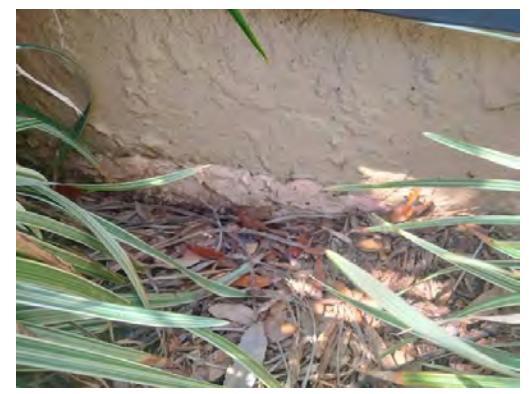
174 Unit 114 - Erosion at Foundation
